BUILDING INSPECTION REPORT

HAWK EYE
BUILDING INSPECTIONS

123 Sample Street Hastings 4120
Inspection prepared for: Valued Customer
Real Estate Agent: Private Sale
Date Of Inspection: 16/10/2021 11.00am
Age Of Home: Approximately 1965
Size Of Home: 2 bedroom, 1 bathroom, 1 carport approximately 80 sqm

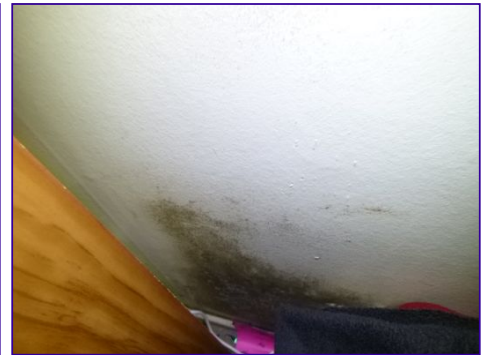
1.2. High moisture readings and mould observed to the exterior facing wall, recommend further invasive review by a licensed builder/building surveyor for timber deterioration, moisture/mould as this can be a structural or health issue. Please note that during a non invasive inspection the inspector cannot determine internal framing condition or extent of moisture.

Mould and high moisture reading

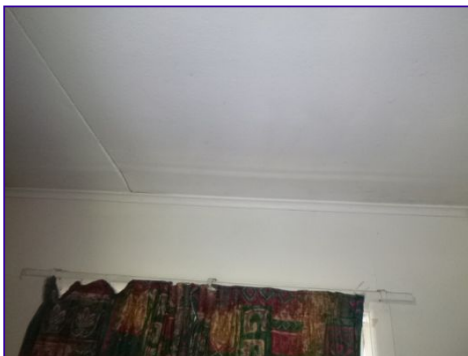
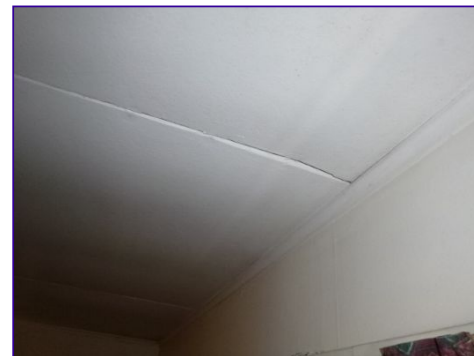
2.1. Sagging ceiling lining noted, recommend a licensed builder repairs to restore function and safety.

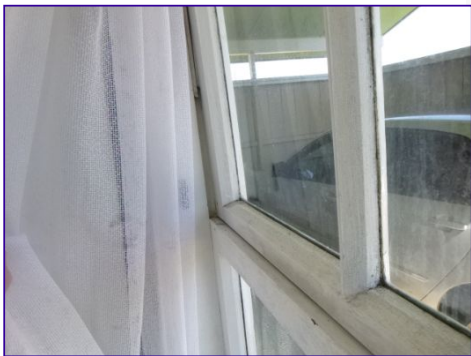
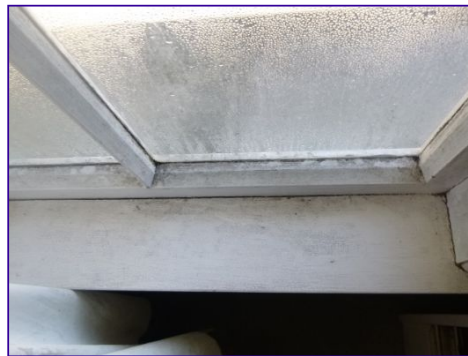
3.2. Peeling paint and mould observed, recommend cleaning, scraping and painting to adequately protect

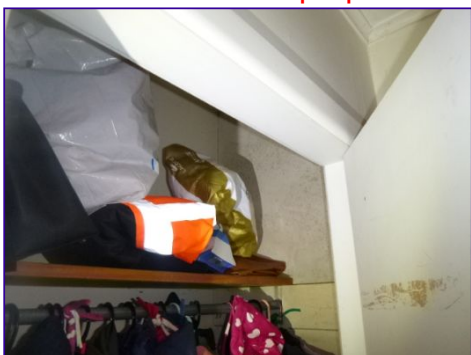
4.2. High moisture reading and mould observed to lining, recommend further invasive review and repairs/replacement of lining by a licensed builder for health purposes

High moisture readings and mould observed to the exterior facing wall and wardrobe, recommend further invasive review by a licensed builder/building surveyor for timber deterioration, moisture/mould as this can structural or health issue. Please note that during a non invasive inspection the inspector cannot determine internal framing condition or extent of moisture.

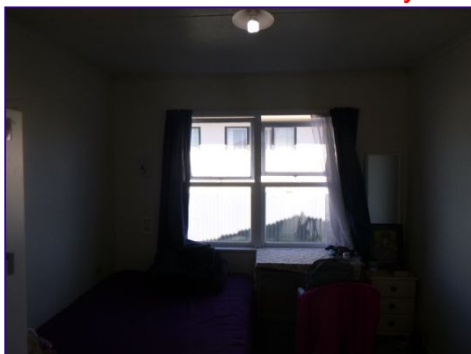
1.2. Elevated moisture reading and mildew observed to the exterior facing wall, recommend further invasive review by a licensed builder/building surveyor.

Elevated reading

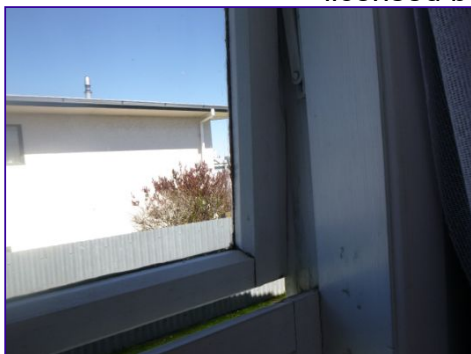
2.2. Wood rot observed to window , recommend repairs/replacement by a licensed builder to improve condition

Elevated moisture metre reading observed to exterior facing wall, recommend further invasive review by a licensed builder
 Recommend repairs /replacement of the window joinery

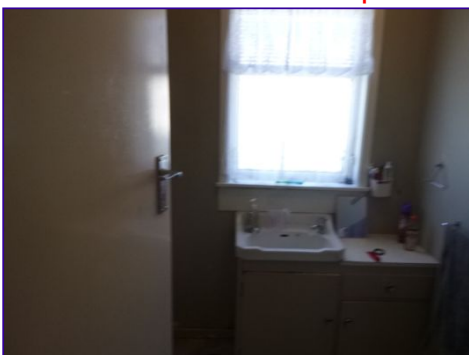
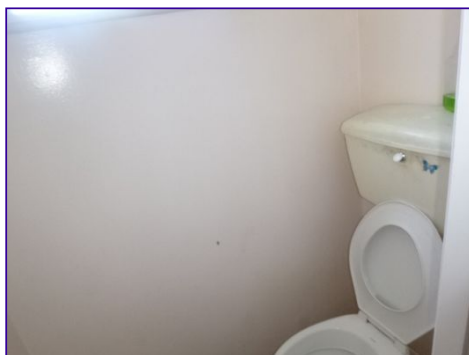
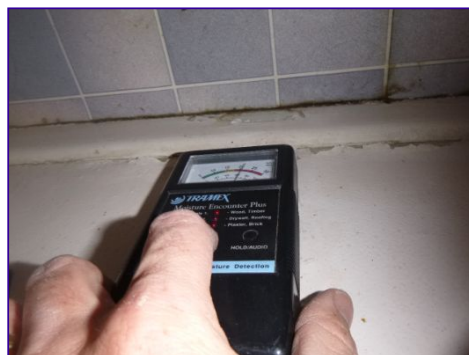
- 2.1. In average condition at the time of inspection
- 2.2. High moisture reading noted on the exterior facing wall, recommend further invasive review by a licensed builder and repairs/replacement as required

High moisture reading

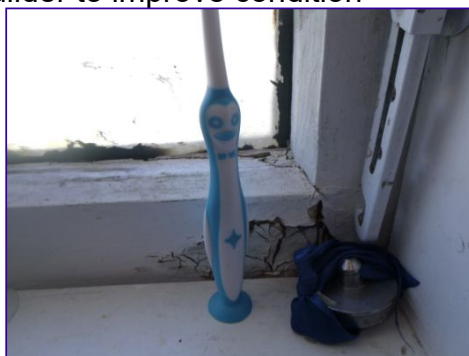
- 5.1. In poor condition at time of the inspection
- 5.2. Wood rot observed to window , recommend repairs/replacement by a licensed builder to improve condition

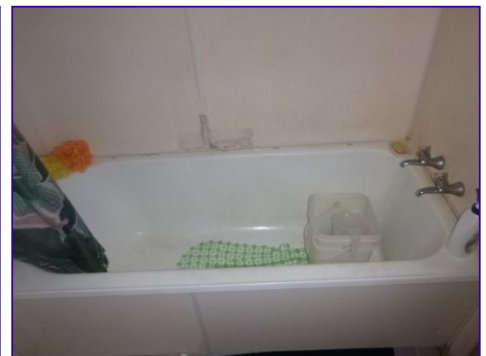
8.1. High moisture reading and deterioration observed near bath surround. Recommend invasive review by a licensed plumber and repairs/replacement as required

High moisture reading

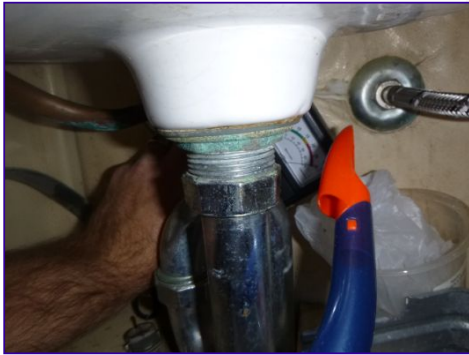
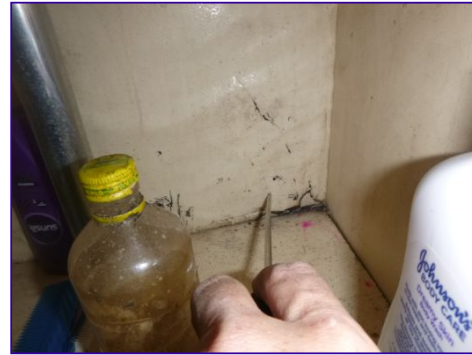
10.1. High moisture reading and evidence of water damage observed, recommend further invasive review by a licensed plumber and repairs/replacement as required

High moisture readings observed near plumbing fixtures and exterior walls, it is recommended further invasive review by a licensed plumber and builder and repairs/replacement as required

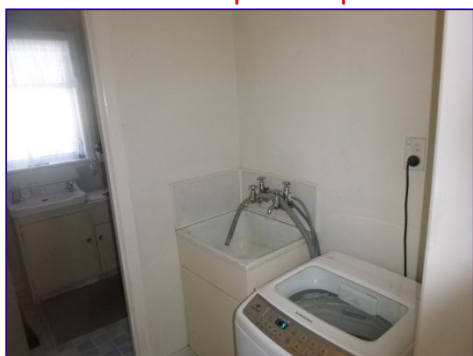
2.2. Unstable internal wall and high moisture metre reading observed near tub, recommend further invasive review by a licensed builder and repairs/replacement as required to restore structural integrity.

Loose wall

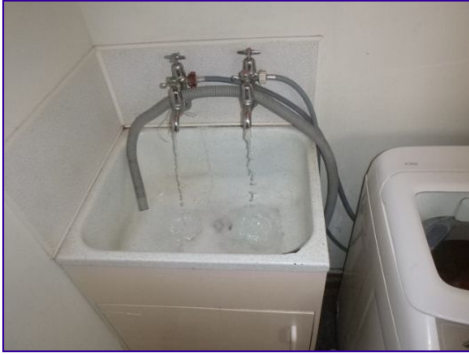
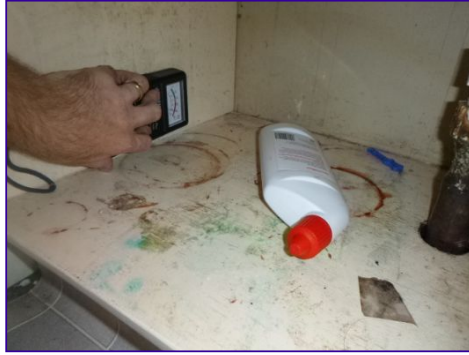
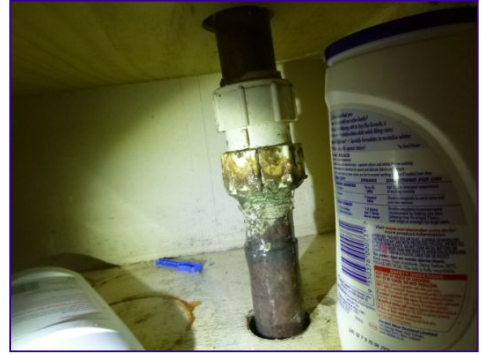
4.1. High moisture reading observed and active leak observed below laundry tub, recommend further invasive review by a licensed plumber, and repairs/replacement as required

High moisture reading

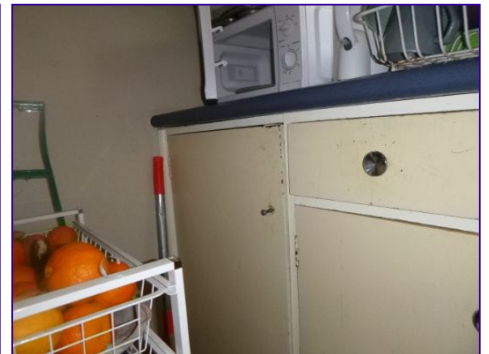
- 5.1. In average condition at the time of inspection
- 5.2. Shelves are sagging and kitchen is in aged condition, recommend repairs/replacement to improve condition

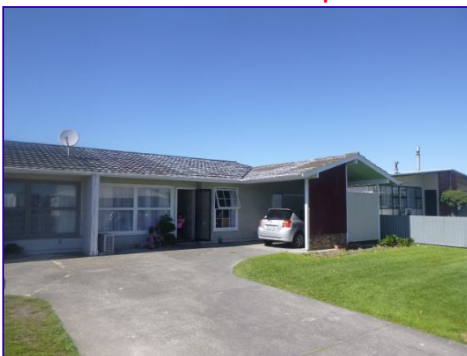
North West wall

- 1.6. **Minor cracks observed to render in areas. Recommend an exterior plasterer repairs/seals to ensure adequate weather protection**

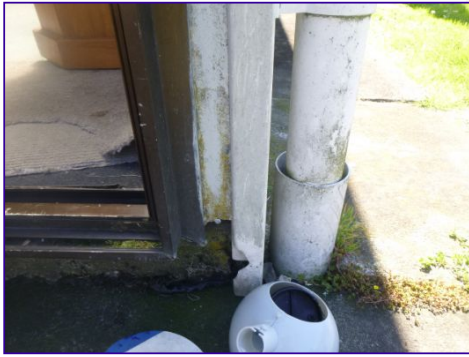
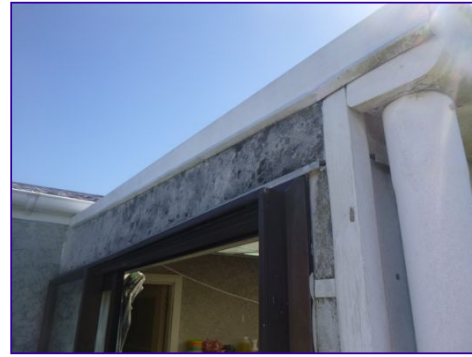
- 5.1. Timber deterioration observed to window joinery, recommend repairs/replacement as required by a licensed builder
- 5.2. Due to high moisture readings and cracking in areas, it is recommended further invasive review by a licensed builder/building surveyor

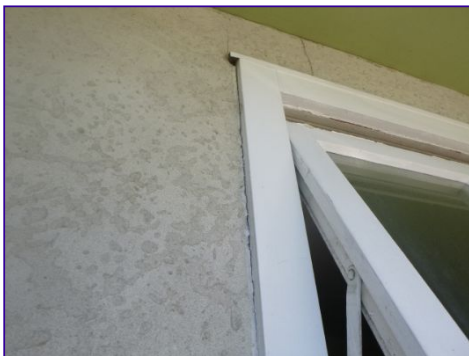
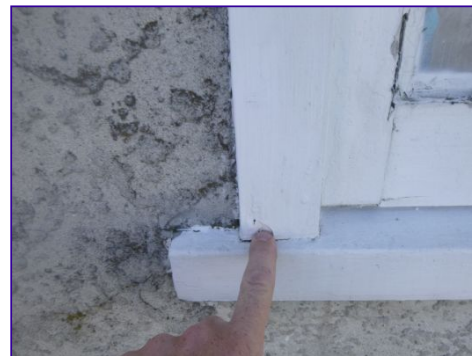
6.3. Wood rot observed to joinery, recommend review by a licensed builder for repairs/replacement as required to restore condition and prevent further deterioration

- 6.1. In poor condition at time of the inspection
- 6.2. Recommend a licensed painter seals around windows/door frames and paint as necessary to maintain adequate protection
- 6.3. Wood rot observed to joinery, recommend review by a licensed builder for repairs/replacement as required to restore condition and prevent further deterioration

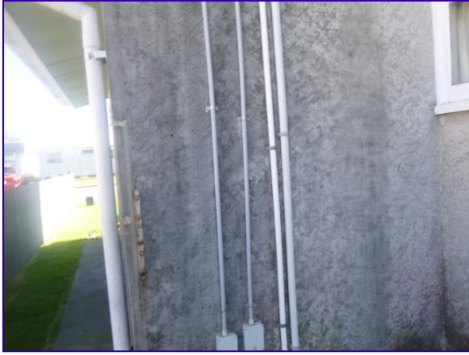
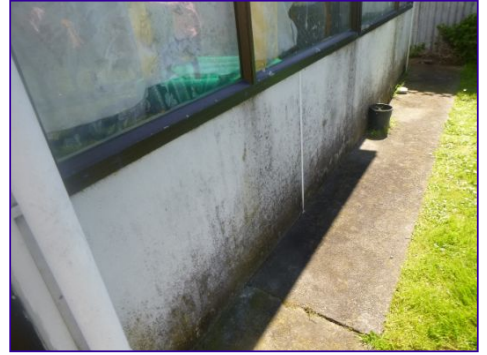
8.2. Protective paint coating is in aged condition, recommend review by a qualified painter to prep and paint to ensure adequate water protection

- 8.1. Monolithic cladding type installed, it is important to maintain protective paint coating to a high standard to prevent water ingress and any cracking is sealed immediately
- 8.2. Protective paint coating is in aged condition, recommend review by a qualified painter to prep and paint to ensure adequate water protection

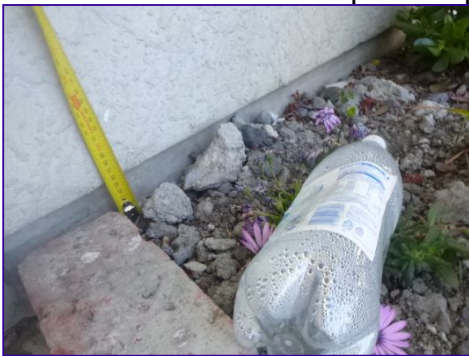
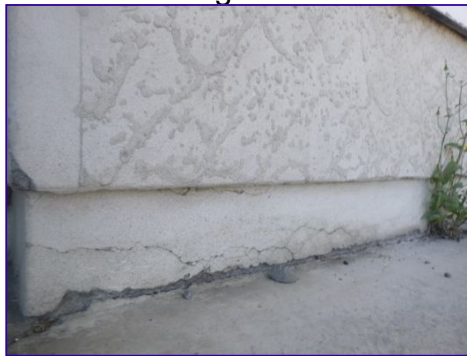
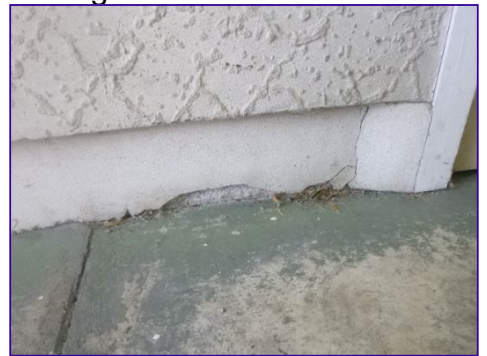
- 9.1. The visible slab edge found to be in average condition at the time of inspection
- 9.2. Minimum ground clearances are average around the home. Ground clearances aid in preventing rising damp issues. The recommended clearances are 150mm above paving and 225mm above soil
- 9.3. Cracking observed to cement parging, recommend an exterior plasterer repairs to prevent water ingress and further cracking

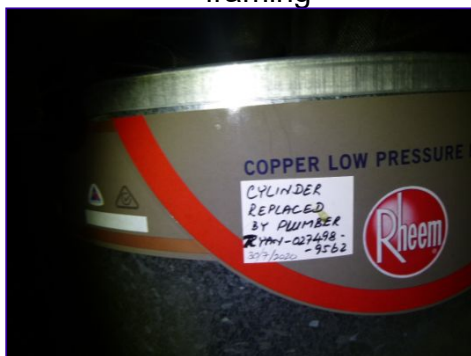
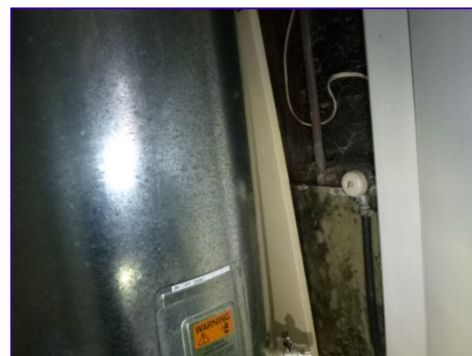
- 10.1. This unit was in working condition at the time of the inspection.
- 10.2. Unit Manufacture date: 2020
- 10.3. Electric hot water storage unit
- 10.4. Mould and wood deterioration observed in the hot water cylinder cupboard, recommend review for repairs/replacement is required of lining and framing

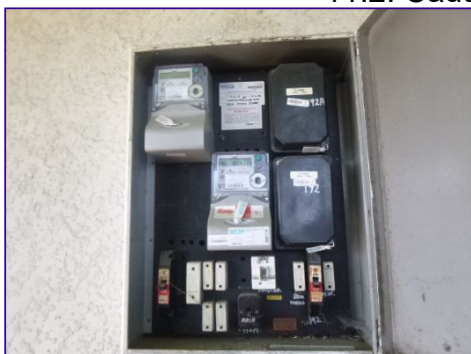
11.2. Caution note: Black backing board may contain asbestos

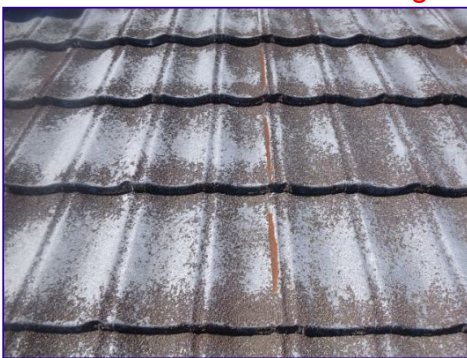
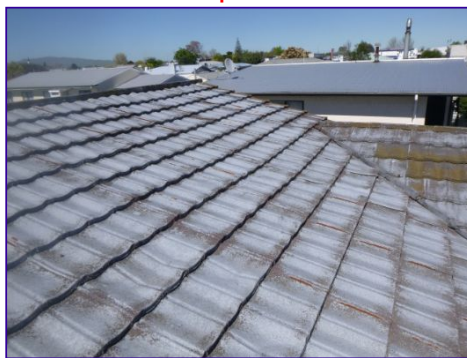
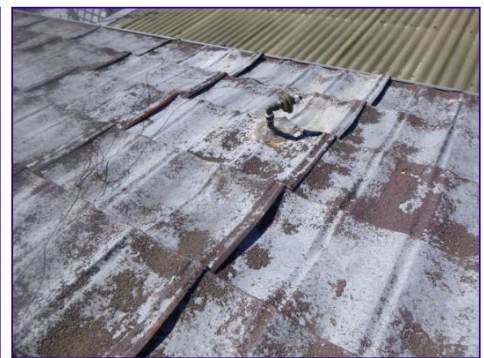
2.3. Original decromastic tile roof installed, surface corrosion, dents and deterioration to the protective paint coating observed, recommend review by a qualified roof painter to repair, prep and paint to adequately protect and extend lifespan, or replacement in the near future as the roof is considered nearing the end of its life span

- 2.1. Roof appeared in average condition at the time of inspection
- 2.2. Caution note: Decromastic tiles of this era may contain asbestos. While undisturbed it is considered safe. If renovating then testing and the correct safety precautions are recommended
- 2.3. Original decromastic tile roof installed, surface corrosion, dents and deterioration to the protective paint coating observed, recommend review by a qualified roof painter to repair, prep and paint to adequately protect and extend lifespan, or replacement in the near future as the roof is considered nearing the end of its life span

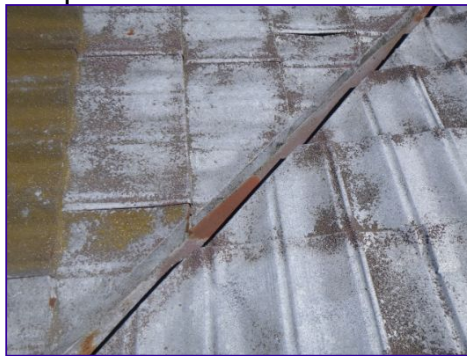
- 3.1. In average condition at time of the inspection
- 3.2. Surface corrosion observed. Recommend a licensed roof painter seal with rust guard paint to extend there life.

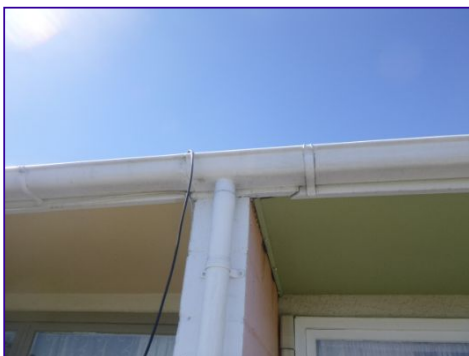
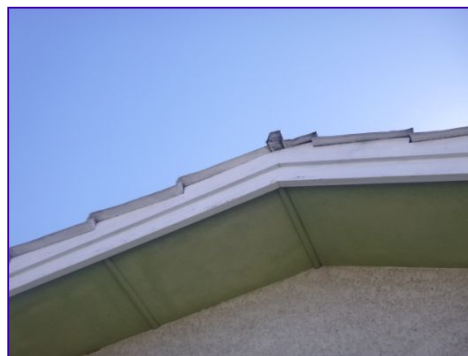
- 5.1. In average condition at the time of inspection
- 5.2. Recommend prepping and painting as part of routine maintenance

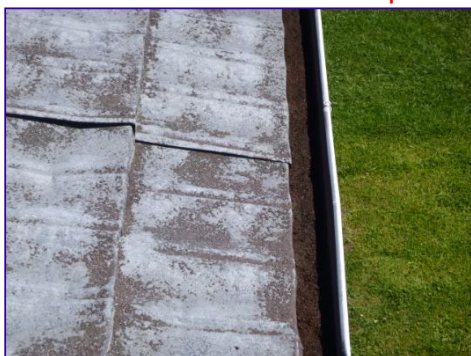
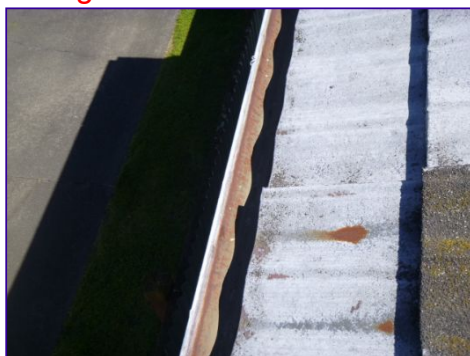
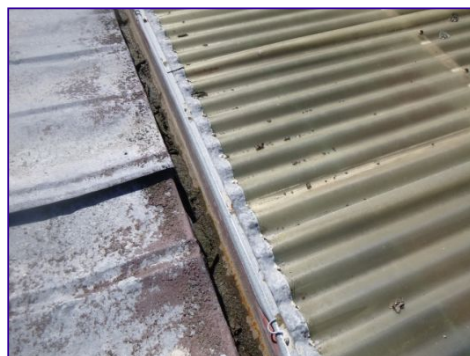
6.3. Decromastic stone chip in gutters may contain asbestos, recommend a gutter cleaning professional cleans the gutters to make safe and ensure adequate drainage

- 6.1. In average condition at time of the inspection
- 6.2. Surface corrosion observed in areas, recommend ongoing maintenance or replacing the gutters in the near future as they are considered near the end of their lifespan.
- 6.3. Decromastic stone chip in gutters may contain asbestos, recommend a gutter cleaning professional cleans the gutters to make safe and ensure adequate drainage

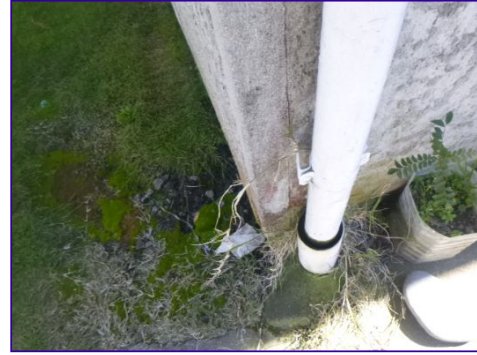
- 7.1. In average condition at the time of inspection, discharging appropriately. Recommend securing gutter to stormwater drain

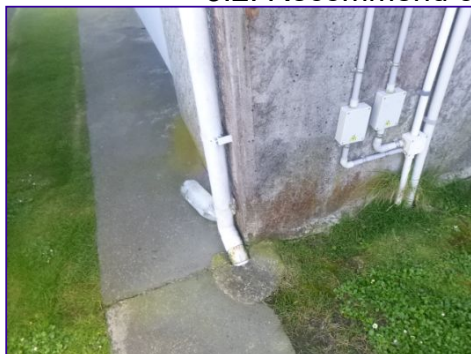
- 3.1. In average condition at the time of inspection, discharging appropriately in the stormwater
- 3.2. Recommend clearing debris from gutters

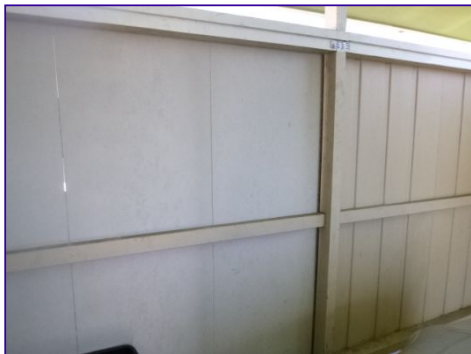
- 5.1. In average condition at the time of inspection
- 5.2. Fibre cement sheet may contain asbestos, recommend washing, prepping and painting to protect and seal
- 5.3. Weatherboard warping, recommend securing and staining where the board to improve condition

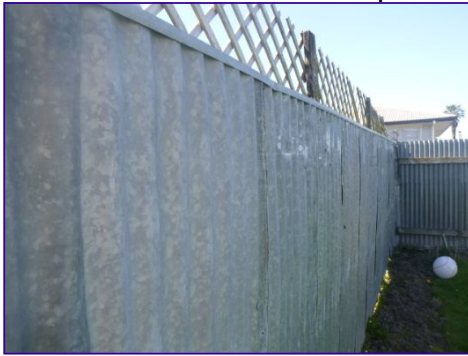
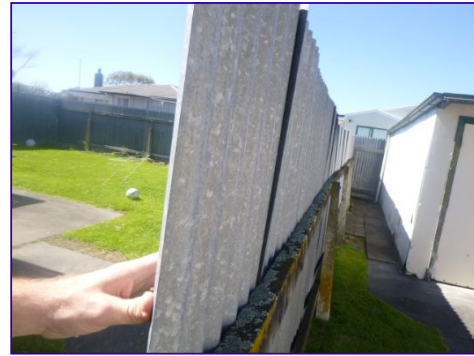
- 5.1. In average condition at time of the inspection
- 5.2. The fence is undulating in areas, recommend repairs by a licensed builder to improve condition
