BUILDING INSPECTION REPORT

HAWK EYE
BUILDING INSPECTIONS

321 Sample Street Napier 4112
Inspection prepared for: Valued Customer
Real Estate Agent: Private Sale
Date Of Inspection: 1/10/2021 11.00 am
Age Of Home: Approximately 2009
Size Of Home: 4 bedroom, 2 bathroom, 2 garage approximately 210 sqm

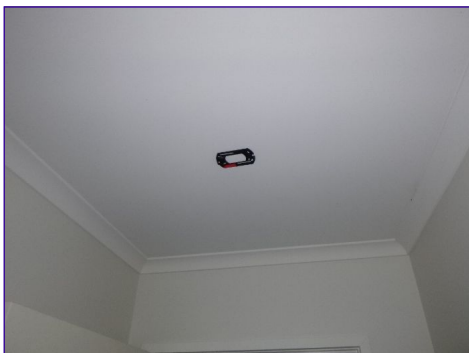
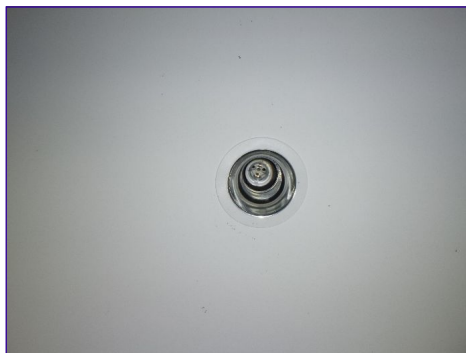
2. Ceiling Conditions

- 2.1. In satisfactory condition at time of the inspection
- 2.2. Recommend replacement of missing light bulb to ensure correct function

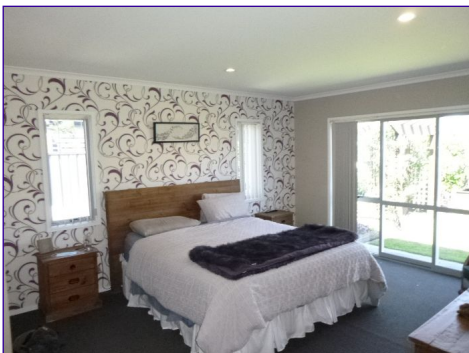
1. Wall Condition

- 1.1. In satisfactory condition at the time of inspection
- 1.2. Dry at the time of the inspection.

Dry at the time of the inspection.

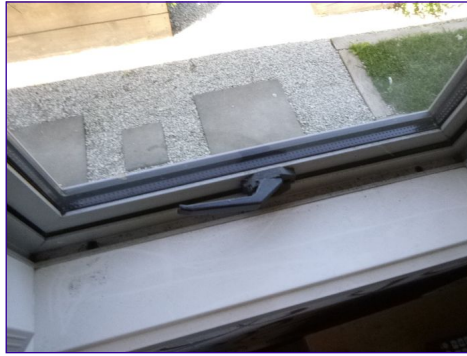
4. Window(s) Condition

4.1. In satisfactory condition at time of the inspection

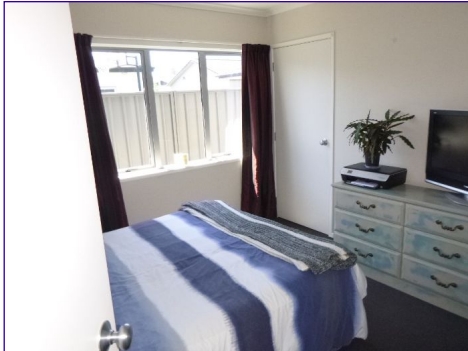
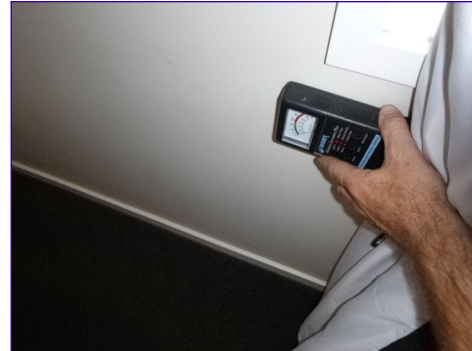
1. Wall Condition

- 1.1. In satisfactory condition at the time of inspection
- 1.2. Dry at the time of the inspection.

Dry at the time of the inspection.

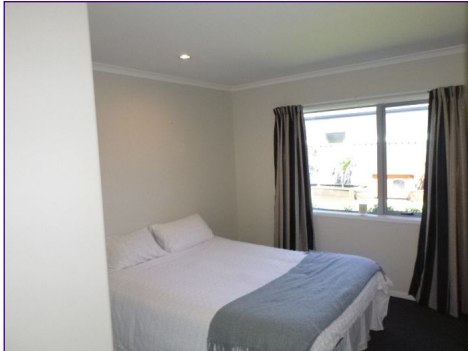
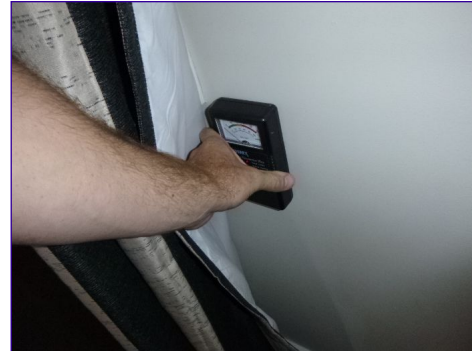
1. Wall Condition

- 1.1. In satisfactory condition at the time of inspection
- 1.2. Dry at the time of the inspection.

Dry at the time of the inspection.

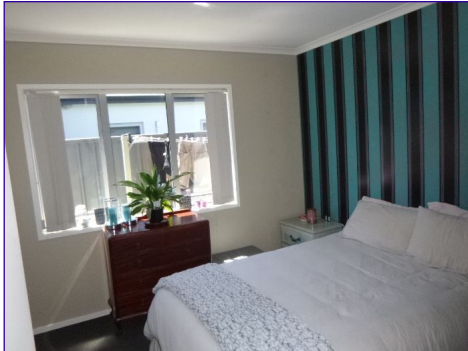
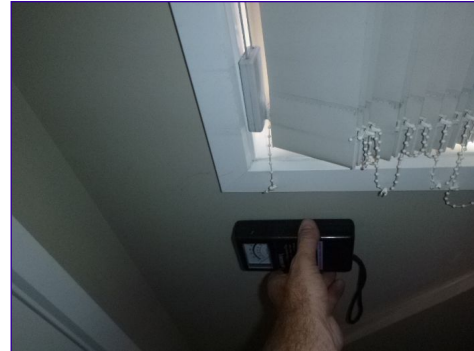
1. Wall Condition

- 1.1. In satisfactory condition at the time of inspection
- 1.2. Dry at the time of the inspection.

Dry at the time of the inspection.

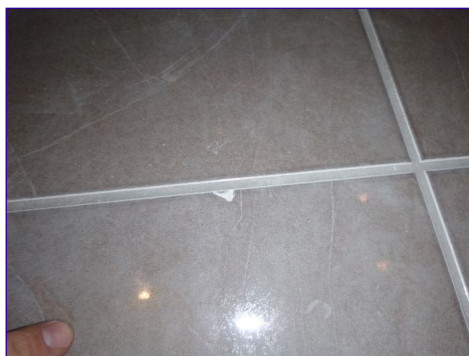
3. Floor condition

- 3.1. In satisfactory condition at time of the inspection
- 3.2. Small chip observed to floor tile

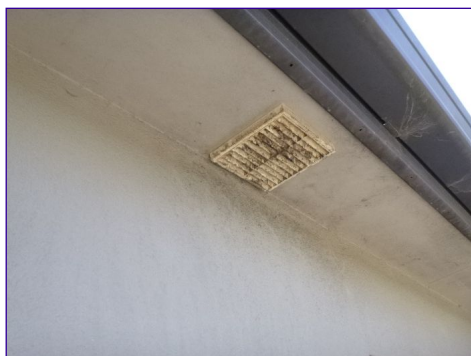
- 4.1. In serviceable condition at the time of inspection
- 4.2. Exterior vented

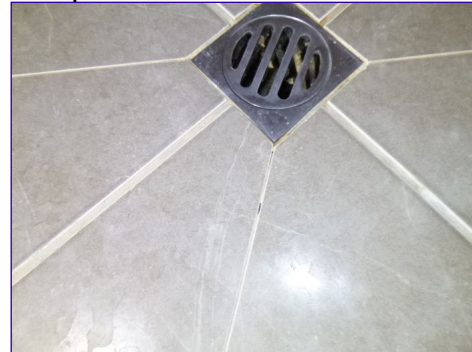
5. Shower Base Condition

5.1. Tiled shower base installed. Please note it is vital to maintain grout and seal to a high standard to prevent water ingress into substrate

5.2. Leak observed under shower glass screen, recommend review by a licensed plumber to repair as required to prevent leak

High moisture reading and leak observed near shower surround , it is recommended further invasive review by a licensed plumber and repairs/replacement as required

6.2. High moisture reading between shower surround /wall junction and active leak below shower glass screen observed. It is recommended review by a licensed plumber for invasive review and repairs as required. Please note that during a non-invasive inspection inspector cannot determine internal conditions

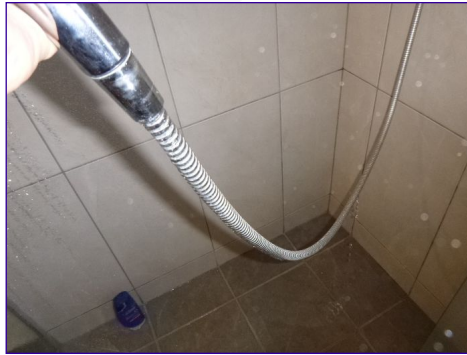
7.1. Shower rose drips. Recommend a licensed plumber repairs/replaces restore function

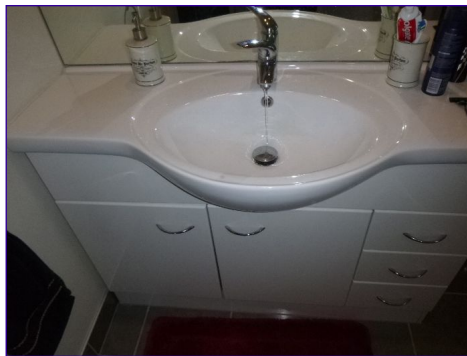
8. Sink/s condition

8.1. In serviceable condition at the time of inspection

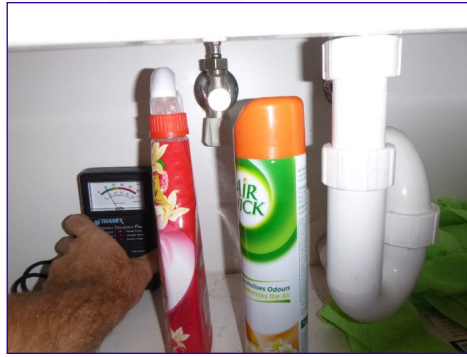
10.1. In serviceable condition at the time of inspection

10.2. Tested dry below sink and no leaks observed at the time of inspection

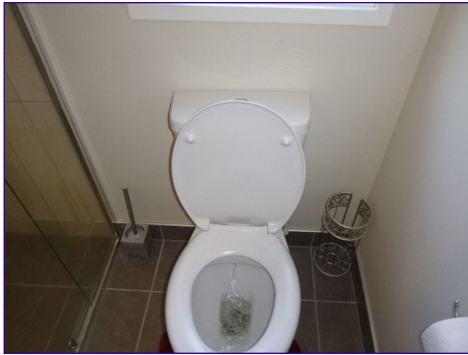
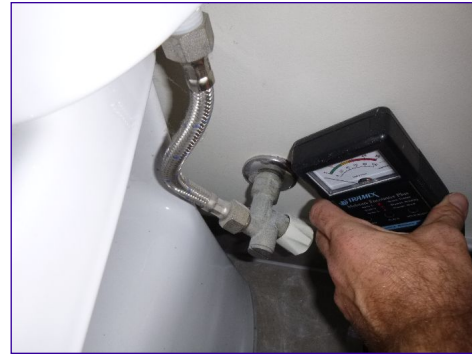
11. Toilet Condition

- 11.1. In serviceable condition at the time of inspection
- 11.2. Tested dry at the time of inspection and no leaks observed

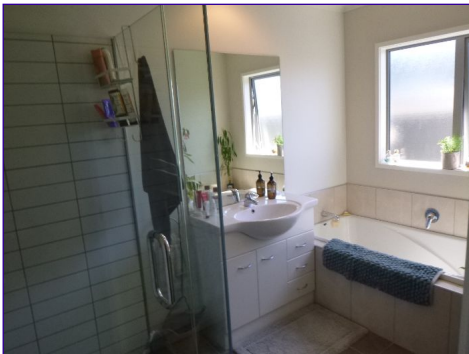
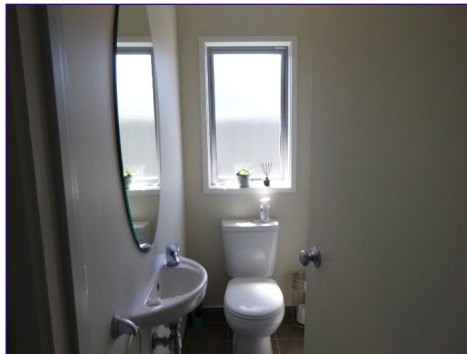
- 2.1. In satisfactory condition at the time of inspection
- 2.2. Dry at the time of the inspection.

Dry at the time of the inspection.

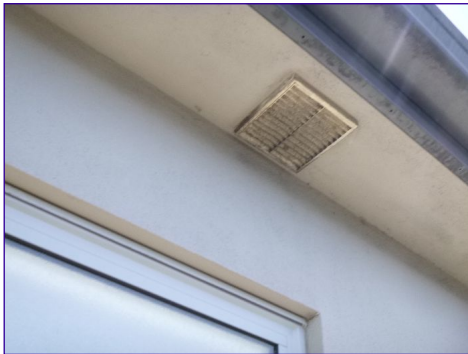
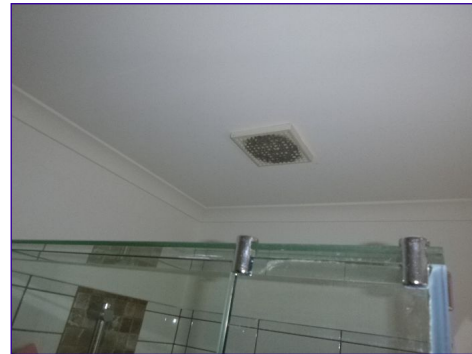
3. Exhaust Fan Condition

- 3.1. In serviceable condition at the time of inspection
- 3.2. Exterior vented

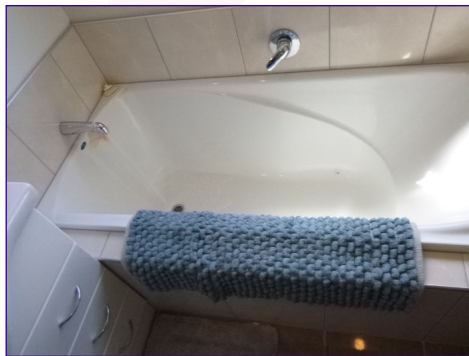
4. Tub/Spa Condition

- 4.1. In serviceable condition at the time of inspection

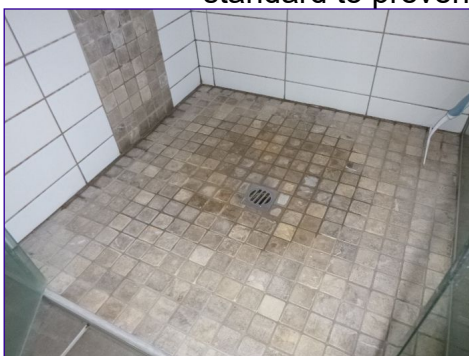
6. Shower Base Condition

- 6.1. In serviceable condition at the time of inspection
- 6.2. Tiled shower base installed. Please note it is vital to maintain grout and seal to a high standard to prevent water ingress into substrate
- 6.3. The perimeter tiles are set of lower than the drain and water is sitting in this area, it is important to maintain the grout and tiles in this area to a good standard to prevent water ingress due to the inadequate drainage

Dry at the time of inspection
Recommend maintaining the tiled shower to a good standard to prevent leaks

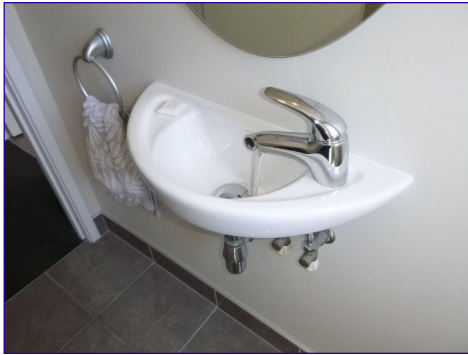
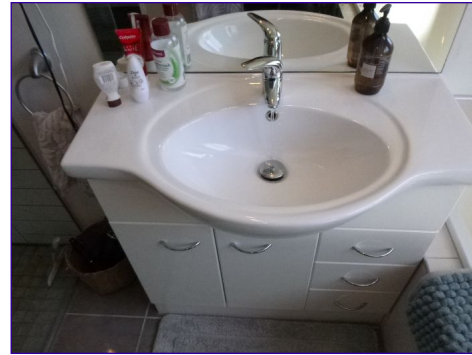
8.1. In serviceable condition at the time of inspection

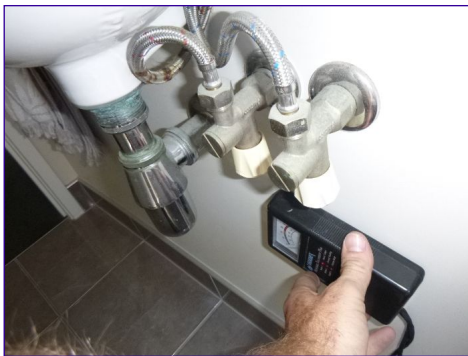
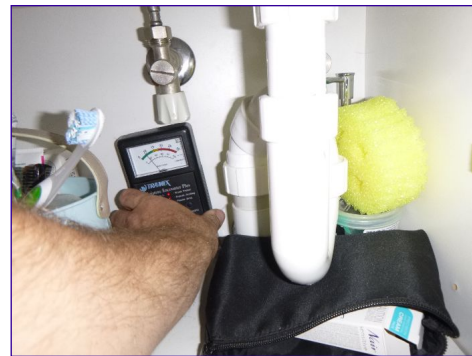
9. Traps/Drains Condition

9.1. In serviceable condition at the time of inspection

9.2. Tested dry below sink and no leaks observed at the time of inspection

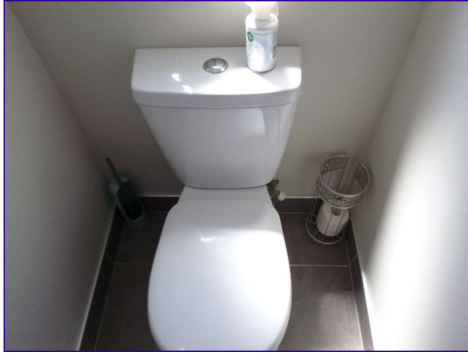
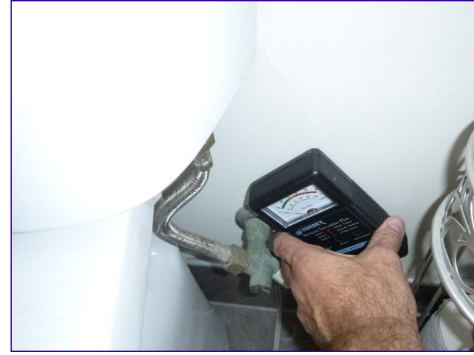
10. Toilet Condition

10.1. In serviceable condition at the time of inspection

10.2. Tested dry at the time of inspection and no leaks observed

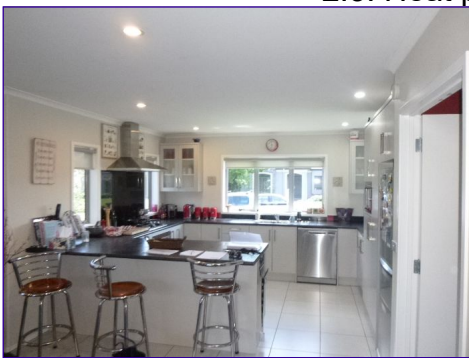
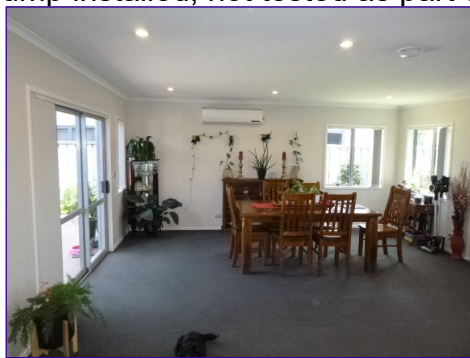
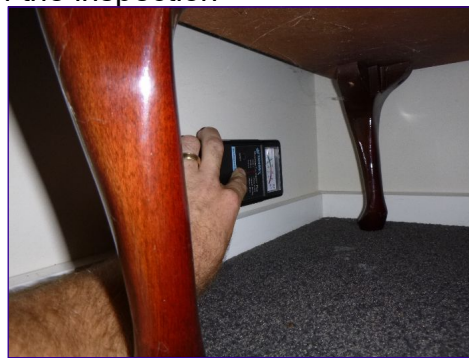
- 2.1. In satisfactory condition at the time of inspection
- 2.2. Dry at the time of the inspection.
- 2.3. Heat pump installed, not tested as part of the inspection

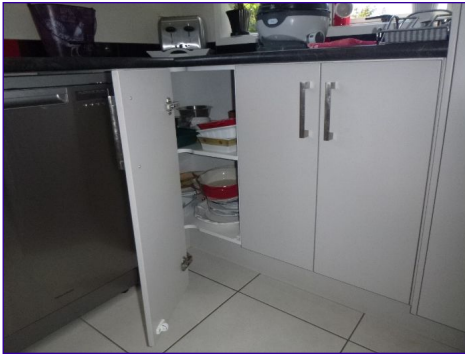
4. Kitchen Cabinet Condition

- 4.1. In serviceable condition at the time of inspection
- 4.2. Swollen/water damage to bottom corner noted

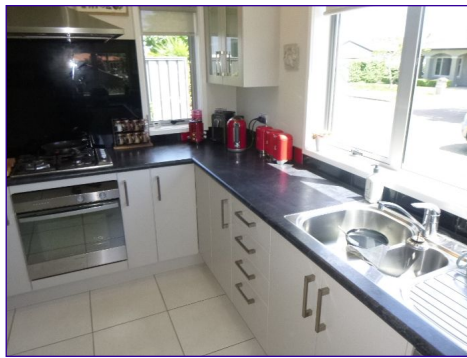
5. Kitchen Bench Top Condition

5.1. In serviceable condition at the time of inspection

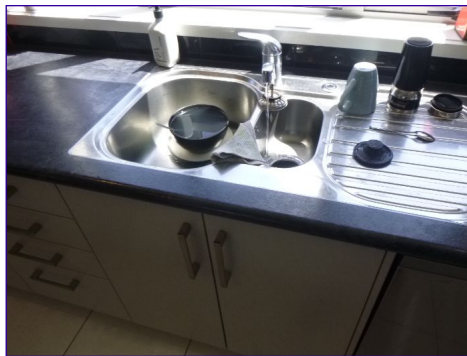
6. Kitchen Sink Condition

6.1. In serviceable condition at the time of inspection

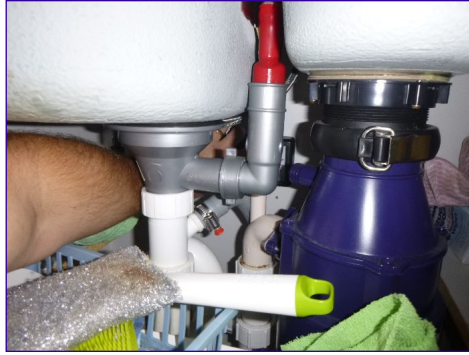
7. Traps/Drains/Supply Condition

7.1. In serviceable condition at the time of inspection

7.2. Tested dry below sink and no leaks observed at the time of inspection

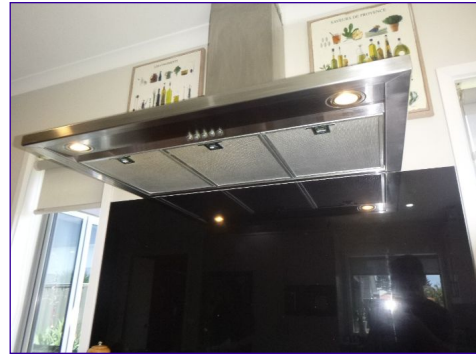
8. Exhaust Fan Condition

Exterior Vented Observations:

8.1. In serviceable condition at the time of inspection

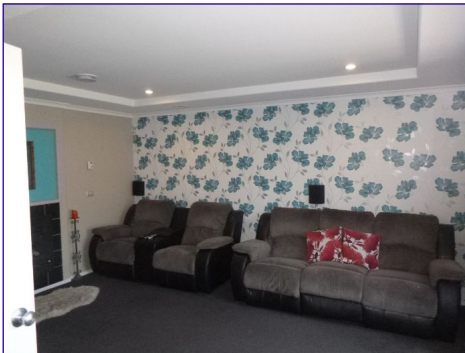
- 1.1. In satisfactory at the time of inspection
- 1.2. Dry at the time of the inspection.
- 1.3. Gas heater installed. Please note that only a licensed gas fitter may inspect these units. This is always recommended as well as cleaning the flue at least once per year before use.

Dry at the time of the inspection.

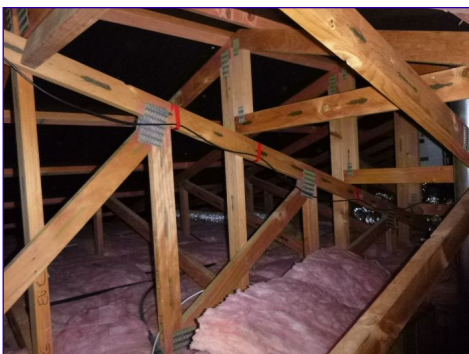
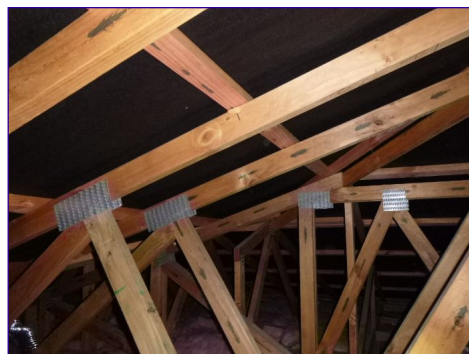
2. Framing Condition

2.1. In satisfactory condition at the time of inspection

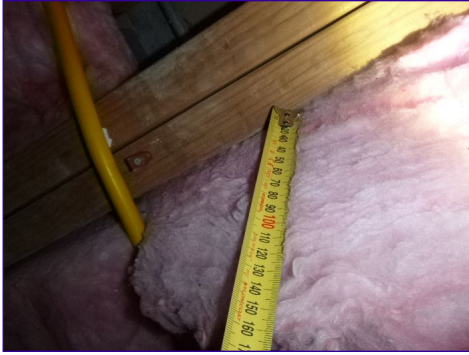
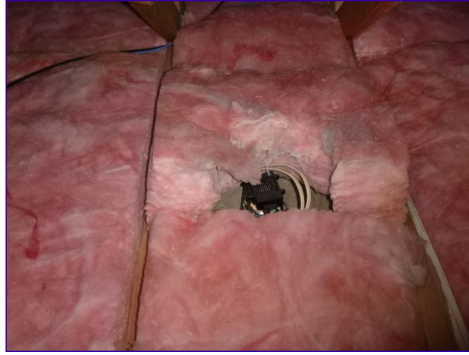
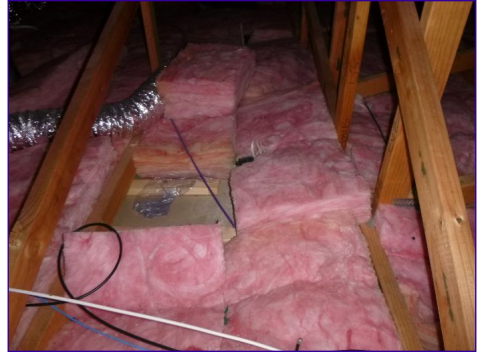
- 4.1. Fibre glass 150mm thickness R value 2.9
- 4.2. The insulation has lifted out of place in areas and is in contact with non-rated recessed lights. It is recommended a insulation contractor redistributes and removes from in contact with lighting to prevent risk of smouldering
- 4.3. Not installed over the garage.

- Recommend maintenance to the insulation to improve safety and efficiency

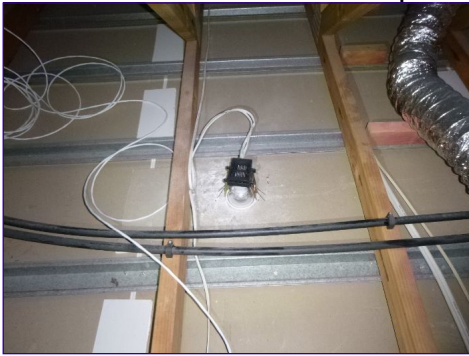
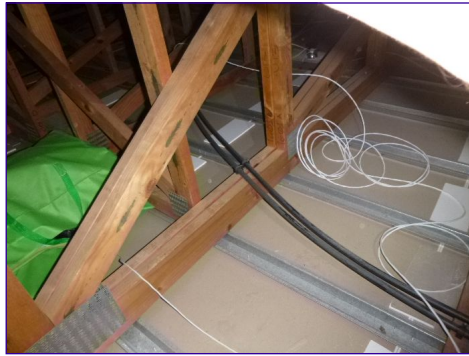
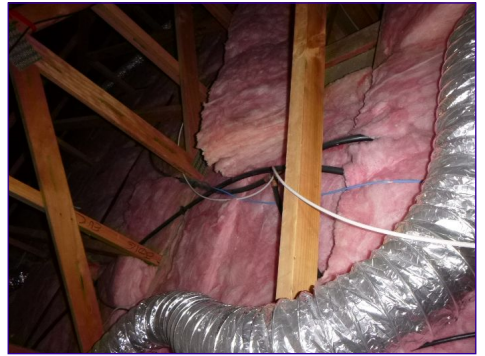
5.1. TPS electrical wiring installed, no concerns observed at the time of inspection

5.2. Plumbing - Installed to a tidy standard and no leaks observed at the time of inspection

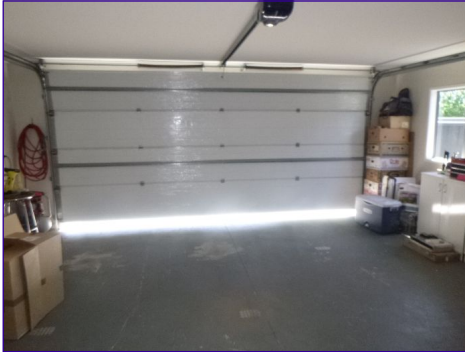
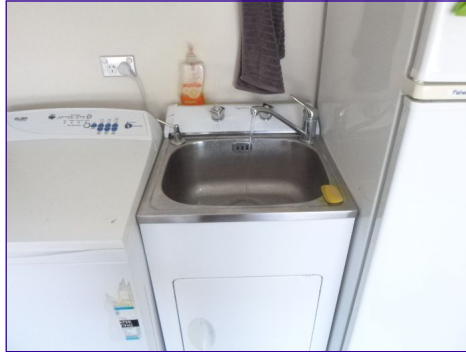
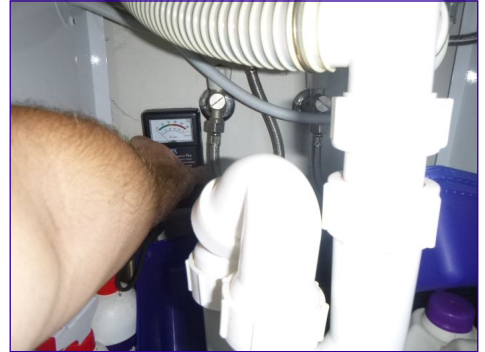
2. Wall Condition

- 2.1. In satisfactory condition at the time of inspection
- 2.2. Dry at the time of the inspection.
- 2.3. Laundry services installed, tested dry and no leaks observed at the time of inspection

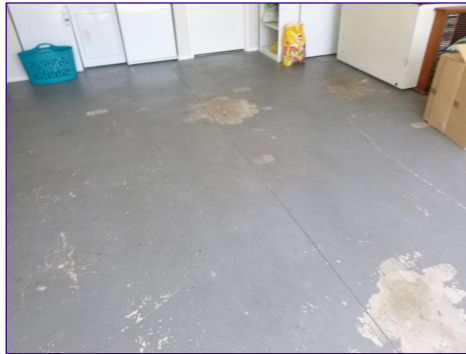
3. Floor Condition

- 3.1. In satisfactory condition at time of the inspection

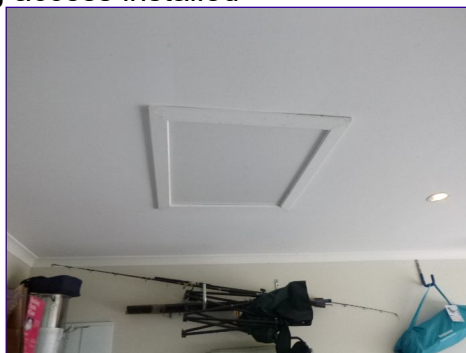
4. Ceiling Condition

- 4.1. In satisfactory condition at the time of inspection
- 4.2. Ceiling access installed

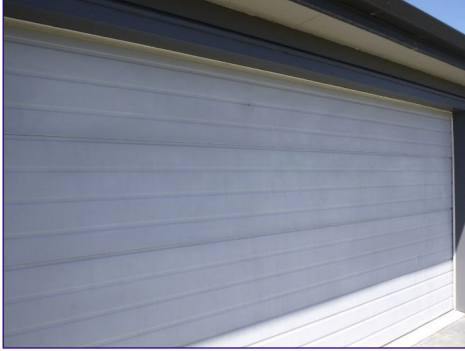
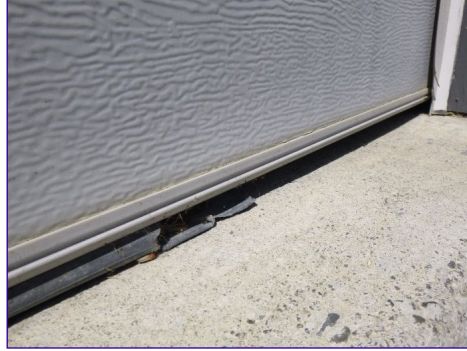
5. Vehicle Door Condition

- 5.1. The garage door electric opener operated properly to raise and lower the door when tested
- 5.2. Bottom weatherstrip is deteriorated, recommend review for repair or replacement, by a garage door specialist to prevent water ingress

- Dry at the time of inspection
- Recommend repairs to the vehicle door weatherstrip

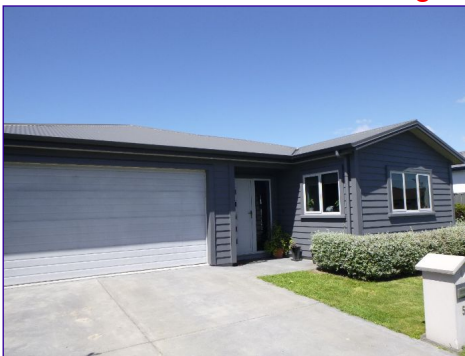
North facing wall

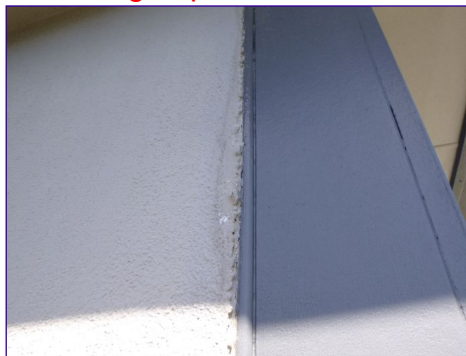
Recommend sealing

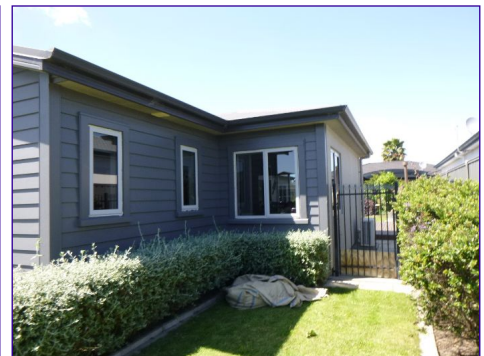
West facing wall

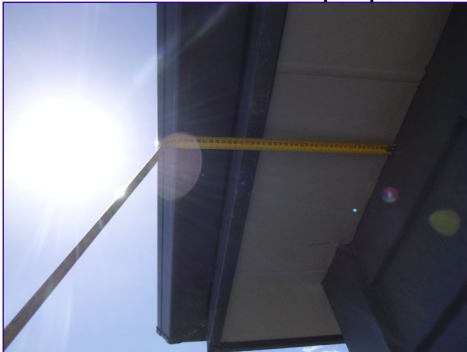
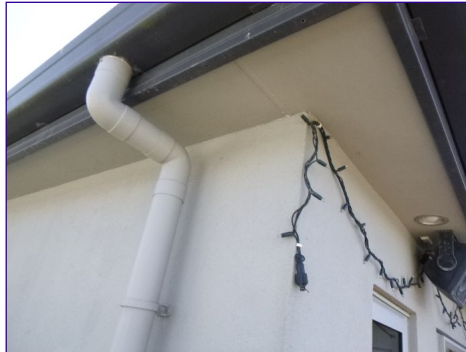
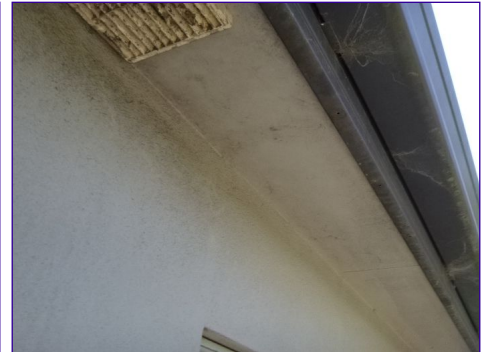
- 2.1. In average condition at time of the inspection
- 2.2. Less than 600mm width to gable ends, this is considered below average for the protection of walls from weathering.
- 2.3. Mould observed in areas, recommend soft washing to clean for health purposes

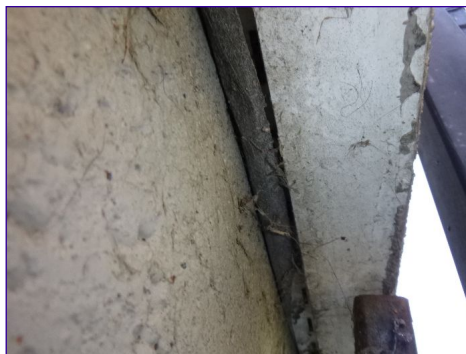
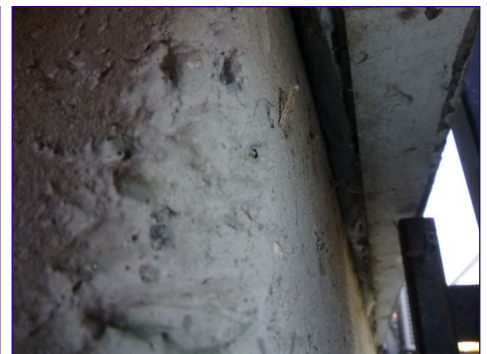
- 4.1. In serviceable condition at the time of inspection

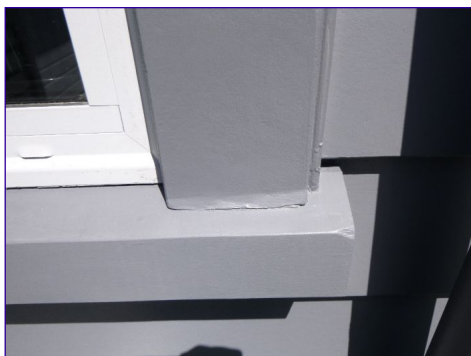
- 6.1. In average condition at time of the inspection
- 6.2. Recommend a qualified painter seals around windows/door frames and paint as necessary to maintain adequate protection
- 6.3. Minor wood softening in areas to timber facings. Recommend repairs/maintenance to protect and prevent further deterioration
- 6.4. Recommend removal of masking tape from West facing windows

Swelling to facings

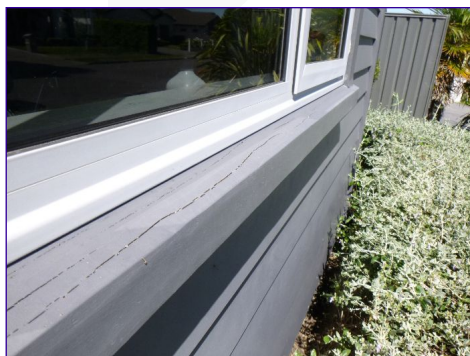
Recommend painting sill

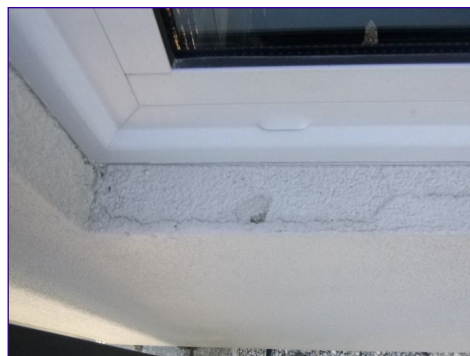
Recommend repairs to sills

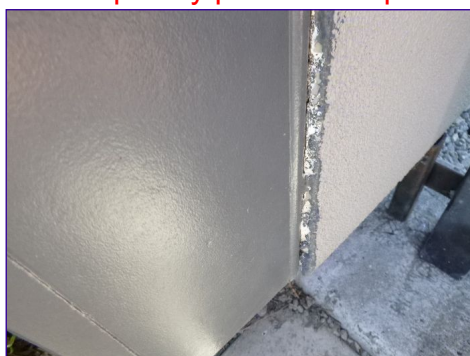
Recommend sealing

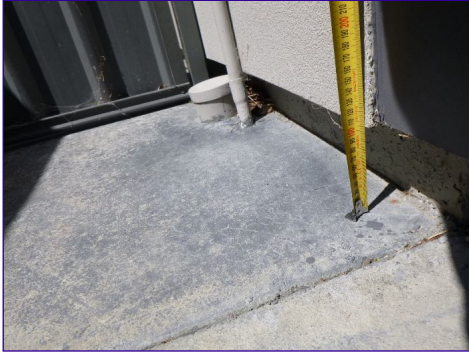
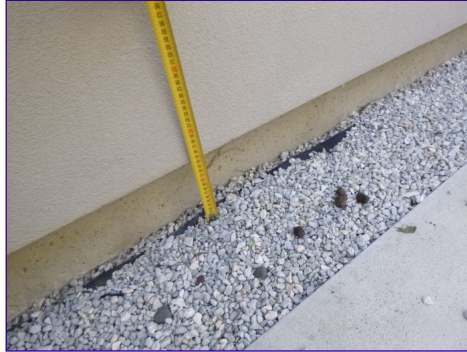
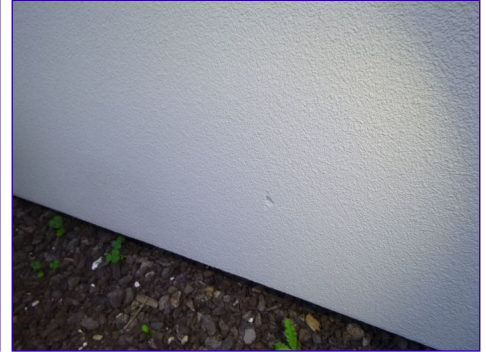
9. Visible Foundation Condition

- 9.1. The visible slab edge found to be in satisfactory condition at the time of inspection
- 9.2. Minimum ground clearances are average around the home. This aids in preventing rising damp issues. The recommended clearances are 150 mm above paving and to 225 mm above soil

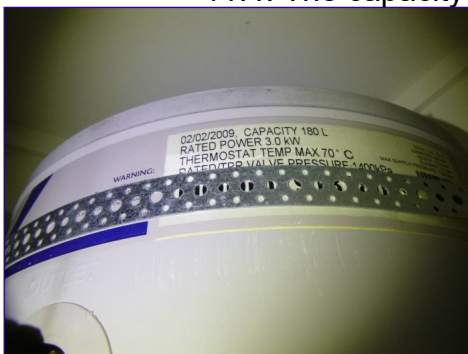
- 11.1. This unit was in working condition at the time of the inspection.
- 11.2. Unit Manufacture date: 2009
- 11.3. Electric hot water storage unit
- 11.4. The capacity of this unit in litres is: 180L

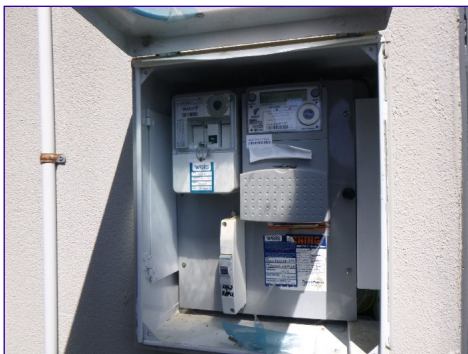
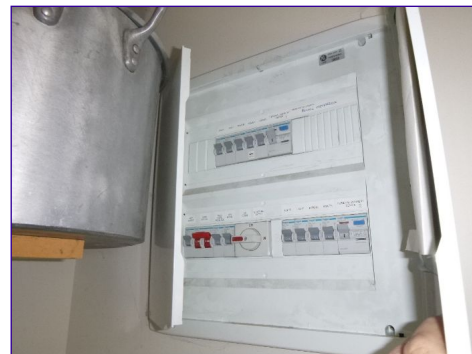
12. Electric Meter

12.1. The electrical wiring appears to be in fair condition.

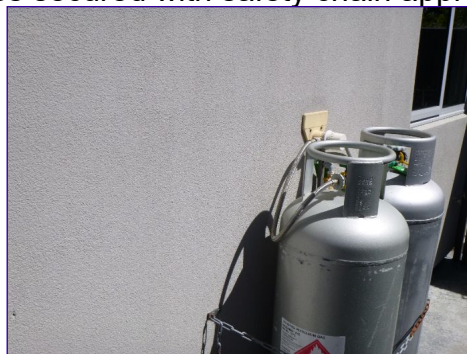
13. Gas supply

13.1. Please note that only a licensed gas fitter may inspect these services. It is always recommended that a gas fitter completes an inspection before handover

13.2. Bottles secured with safety chain appropriately

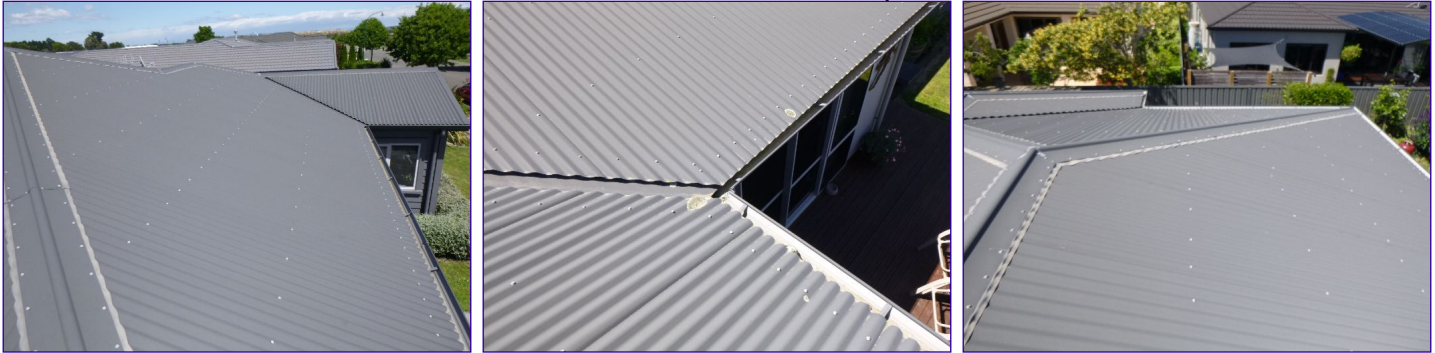
- 2.1. Roof appeared satisfactory condition at the time of inspection
- 2.2. Recommend treatment of moss to prevent moisture retention

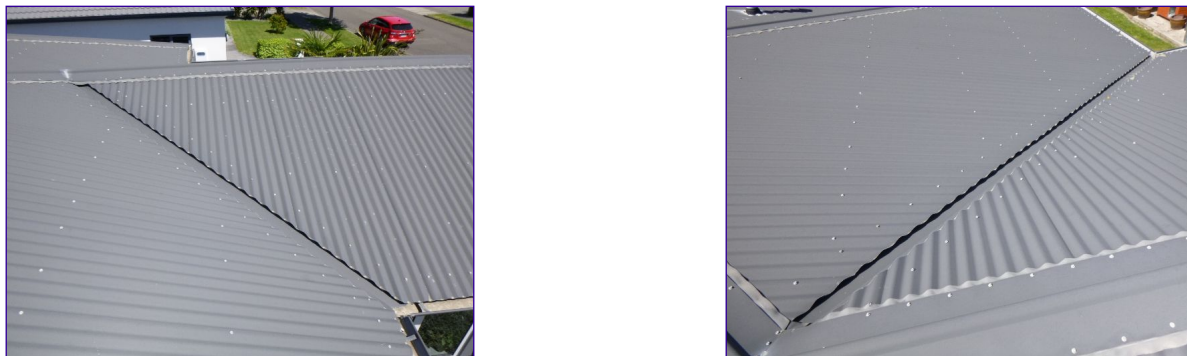
3. Valley condition

- 3.1. In satisfactory condition at time of the inspection

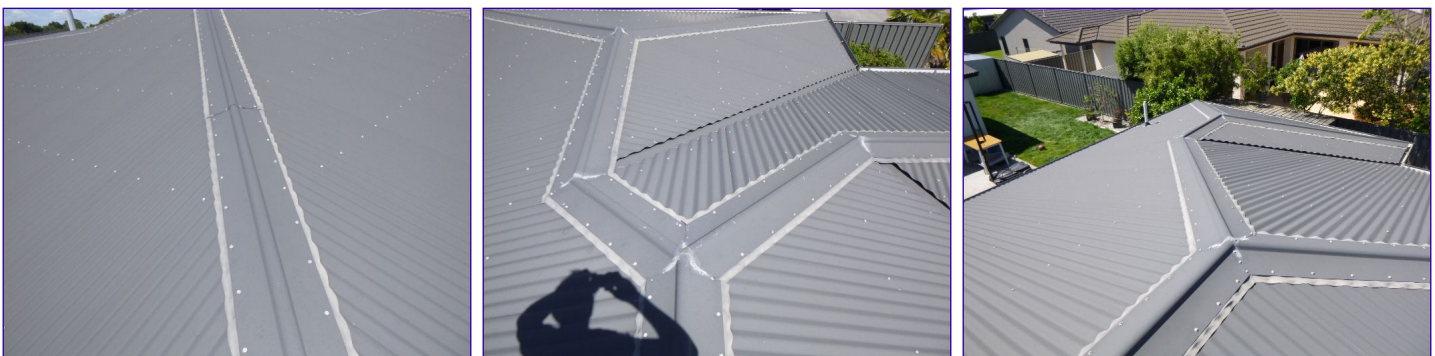
4. Roof Flashing Condition

- 4.1. In satisfactory condition at time of the inspection

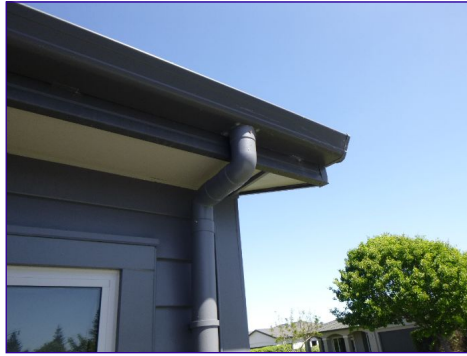
5. Facia/Barges

5.1. In satisfactory condition at the time of inspection

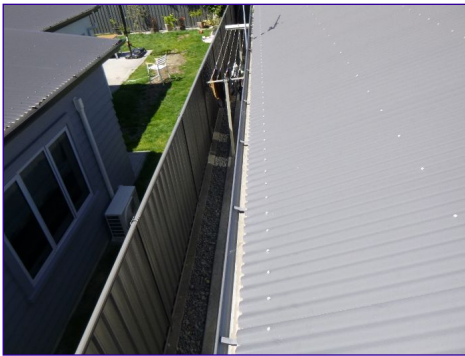
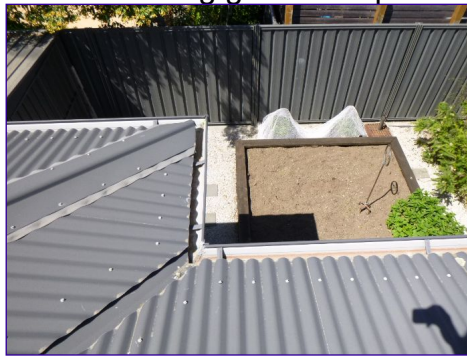
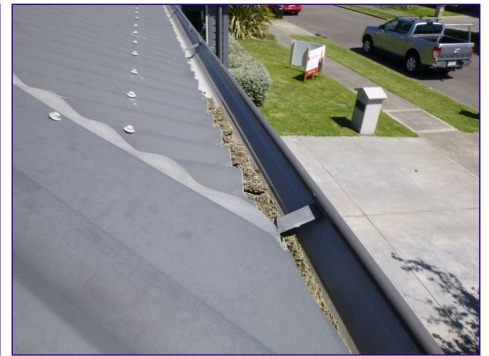
6. Gutter Condition

6.1. In satisfactory condition at time of the inspection

6.2. Recommend cleaning gutters as part of routine maintenance.

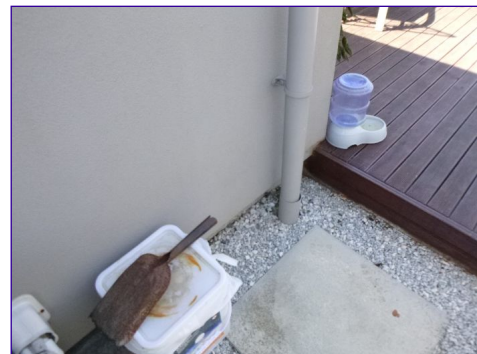
7. Downpipes

7.1. In satisfactory condition, discharging appropriately at the time of inspection

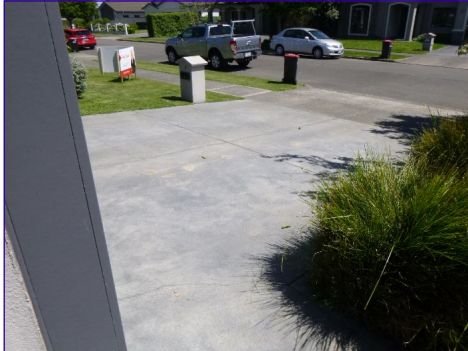
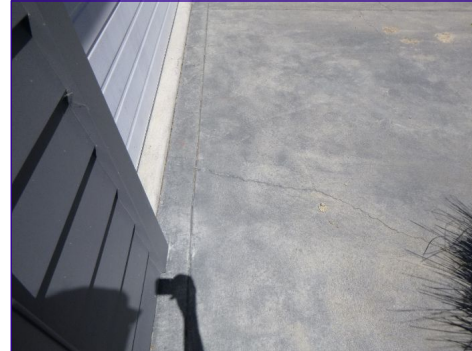
1. Driveway Condition

- 1.1. In satisfactory condition at the time of inspection
- 1.2. Common cracks noted, recommend sealing to prevent water ingress

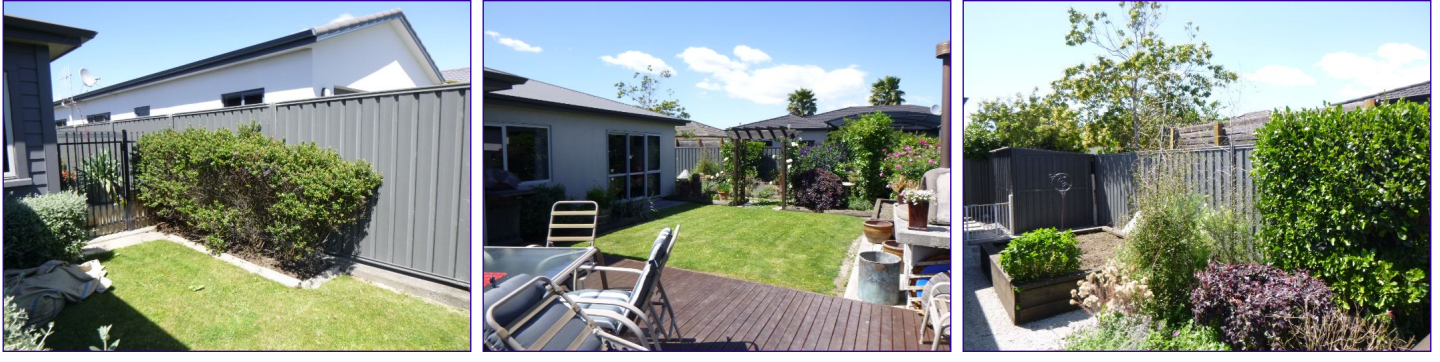
4. Fence Condition

- 4.1. In satisfactory condition at time of the inspection
