BUILDING INSPECTION REPORT

HAWK EYE
BUILDING INSPECTIONS

123 Sample Street Hastings 4120
Inspection prepared for: Valued Customer
Real Estate Agent: Private Sale
Date Of Inspection: 16/10/2021 11.00am
Age Of Home: Approximately 1965
Size Of Home: 2 bedroom, 1 bathroom, 1 carport approximately 80 sqm

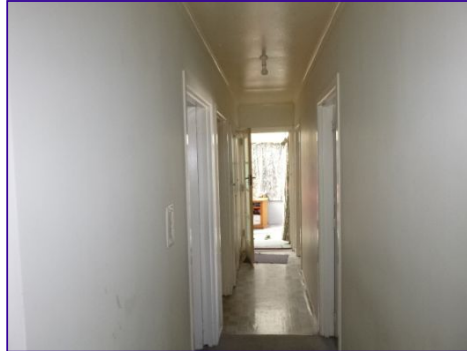
1. Wall Condition

- 1.1. In average condition at the time of inspection
- 1.2. Due to deterioration to linen cupboard it is recommended repairs/replacement by a licensed builder

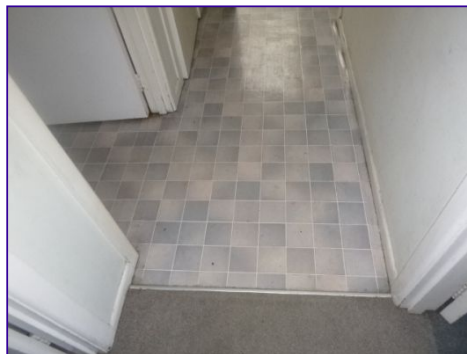
2. Floor Condition

- 2.1. In average condition at time of the inspection
- 2.2. Vinyl of this era may contain asbestos. While left in good condition it is considered safe. If renovating then testing and the correct safety precautions are recommended

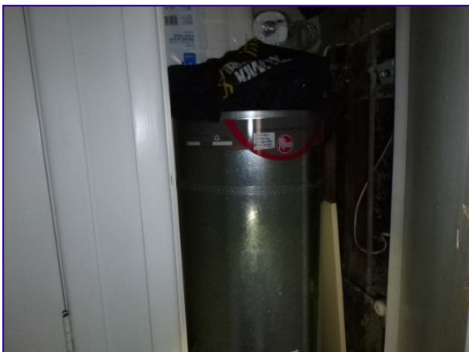
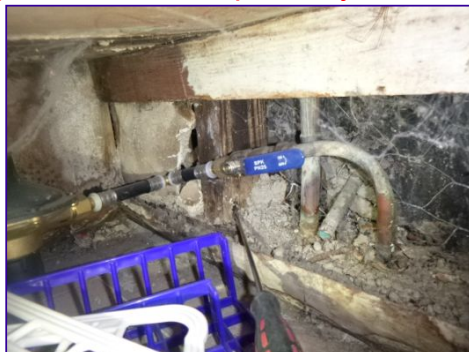
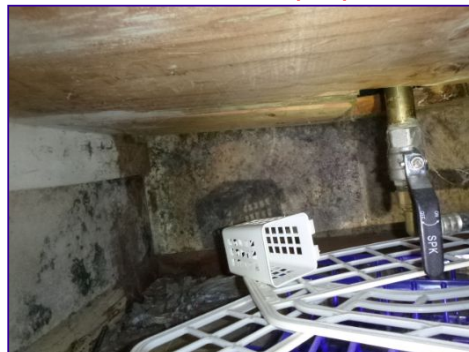
4. Linen Cupboard

4.1. In poor condition at time of the inspection

4.3. Mould and water damaged framing observed in cupboard, recommend removal/replacement as required by a licensed builder for health purposes

No smoke alarm observed. Recommend installing smoke alarms on each level and within 3m of, or in each bedroom for fire safety purposes
 Recommend repairs/replacement of wardrobe lining and framing due to mould and wood deterioration

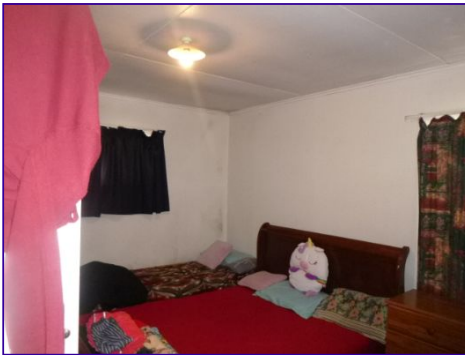
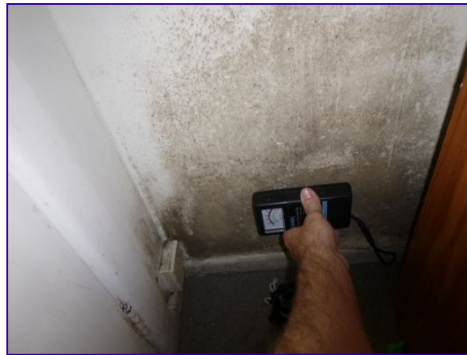
1. Wall Condition

1.1. In poor condition at the time of inspection

1.2. High moisture readings and mould observed to the exterior facing wall, recommend further invasive review by a licensed builder/building surveyor for timber deterioration, moisture/mould as this can be a structural or health issue. Please note that during a non invasive inspection the inspector cannot determine internal framing condition or extent of moisture.

Mould and high moisture reading

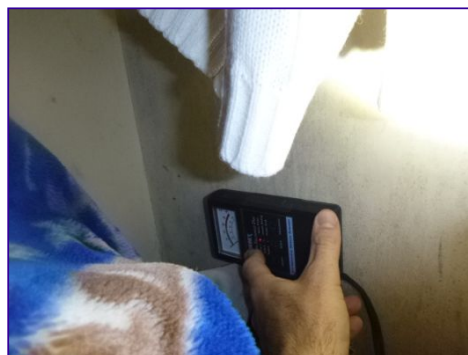
4.1. In average condition at time of the inspection

4.2. High moisture reading and mould observed to lining, recommend further invasive review and repairs/replacement of lining by a licensed builder for health purposes

High moisture readings and mould observed to the exterior facing wall and wardrobe, recommend further invasive review by a licensed builder/building surveyor for timber deterioration, moisture/mould as this can structural or health issue. Please note that during a non invasive inspection the inspector cannot determine internal framing condition or extent of moisture.

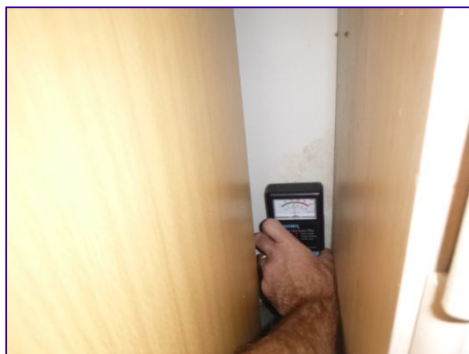
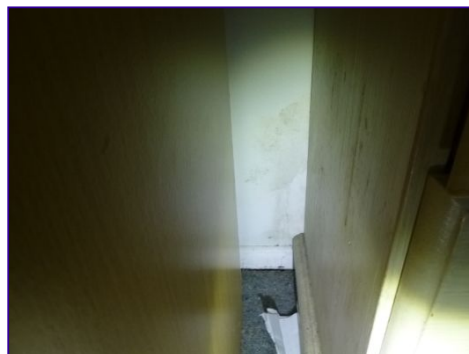
1.1. In average condition at the time of inspection

1.2. Elevated moisture reading and mildew observed to the exterior facing wall, recommend further invasive review by a licensed builder/building surveyor.

Elevated reading

Elevated moisture metre reading observed to exterior facing wall, recommend further invasive review by a licensed builder
 Recommend repairs /replacement of the window joinery

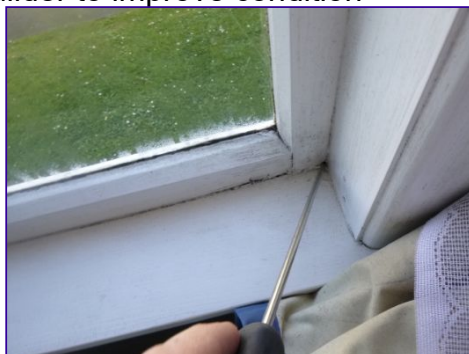
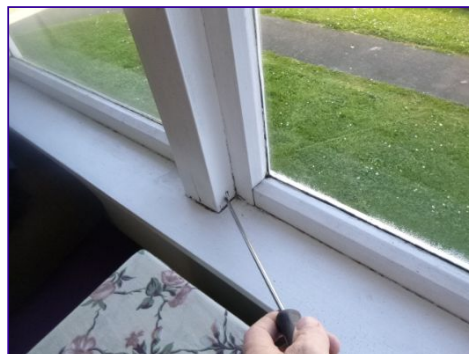
2. Window(s) Condition

2.1. In average condition at time of the inspection

2.2. Wood rot observed to window , recommend repairs/replacement by a licensed builder to improve condition

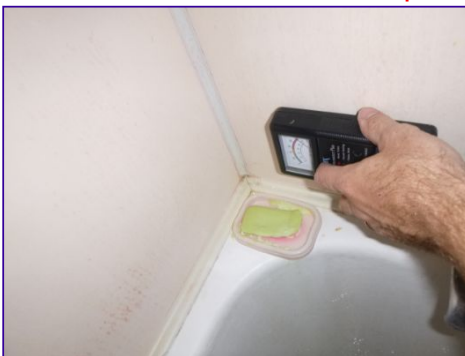
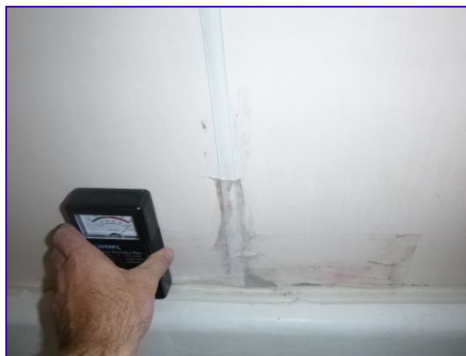
8.1. High moisture reading and deterioration observed near bath surround. Recommend invasive review by a licensed plumber and repairs/replacement as required

High moisture reading

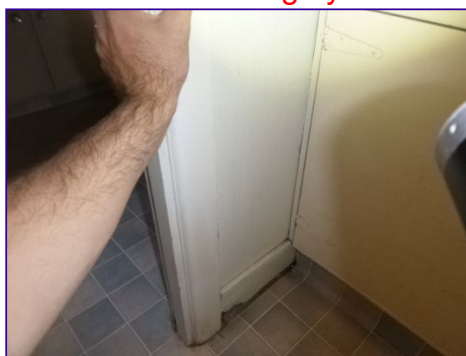
2.1. In poor condition at the time of inspection

2.2. Unstable internal wall and high moisture metre reading observed near tub, recommend further invasive review by a licensed builder and repairs/replacement as required to restore structural integrity.

Loose wall

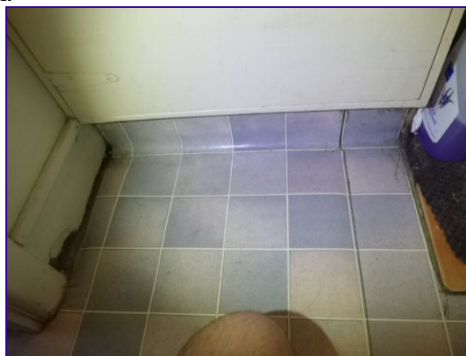
3. Floor Condition

3.1. In average condition at time of the inspection

3.2. Vinyl of this era may contain asbestos. While left undisturbed it is considered safe to the occupants. If renovating then testing and the correct safety precautions are recommended

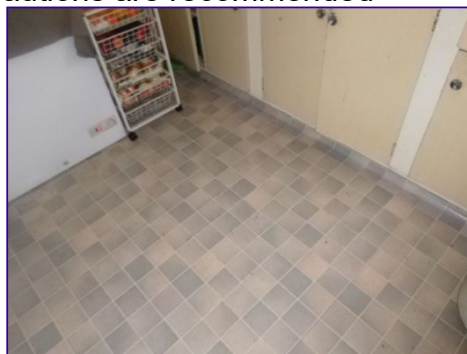
2. Kitchen Floor Condition

- 2.1. In poor condition at time of the inspection
- 2.2. Vinyl of this era may contain asbestos. While left undisturbed it is considered safe to the occupants. If renovating then testing and the correct safety precautions are recommended

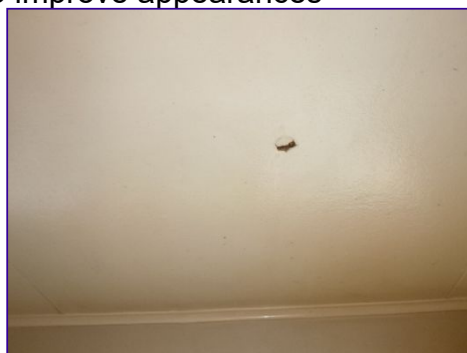
3. Ceiling Conditions

- 3.1. In average condition at time of the inspection
- 3.2. Damaged ceiling lining observed, recommend repairs by an interior plasterer to improve appearances

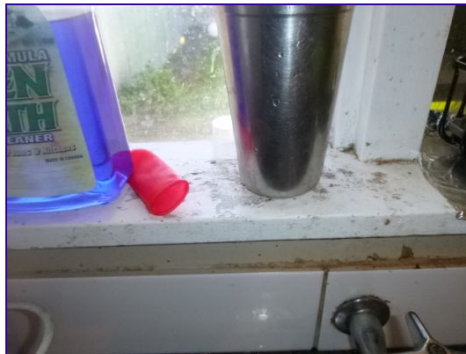
4. Kitchen Windows Condition

- 4.1. In average condition at time of the inspection
- 4.2. Peeling paint observed, recommend scraping and painting to adequately protect

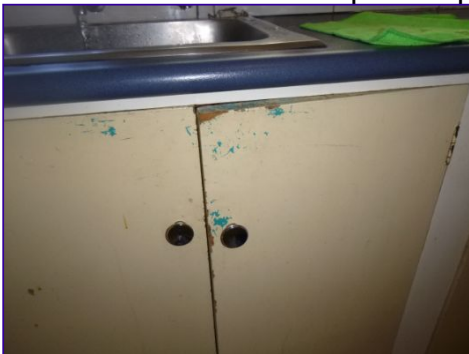
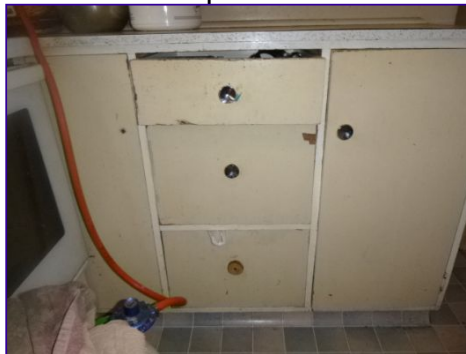
5. Kitchen Cabinet Condition

- 5.1. In average condition at the time of inspection
- 5.2. Shelves are sagging and kitchen is in aged condition, recommend repairs/replacement to improve condition

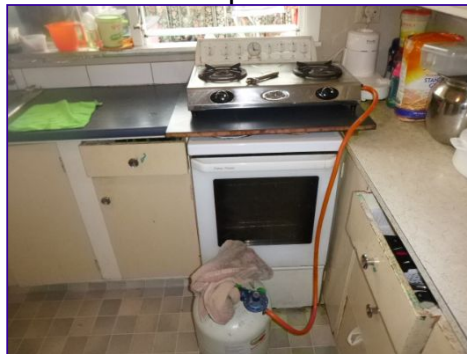
9. Exhaust Fan Condition

- 9.1. Not installed, it is recommended to install an exterior vented fan/range hood to aid in controlling moisture in the kitchen area
- 9.2. Recommend removal of un-flued cooker and gas bottle as this is a health and safety concern to occupants

Dry at the time of inspection
 Recommend removal of gas bottle and cooker for health and safety concerns
 Overall the kitchen is in aged condition

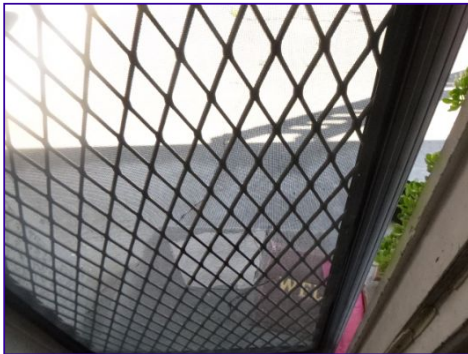
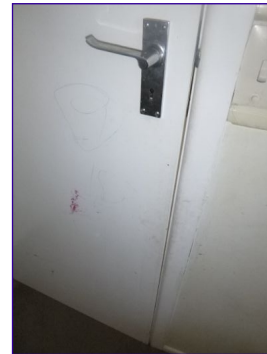
2. Door Conditions

- 2.1. In average condition at time of the inspection
- 2.2. Door binds, recommend a licensed builder sands/planes to ease function
- 2.3. Mesh screen is damaged, recommend a joiner replaces to improve condition

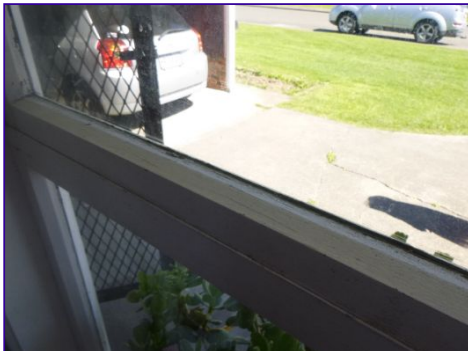
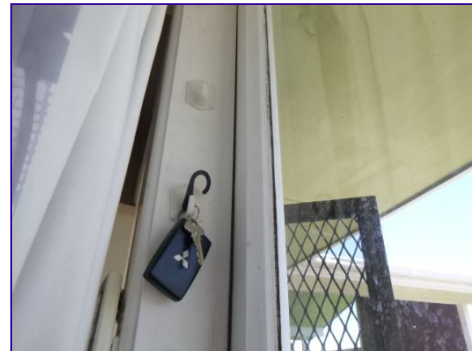
- 3.1. In average condition at time of the inspection
- 3.2. Peeling paint observed, recommend scraping and painting to protect from further deterioration

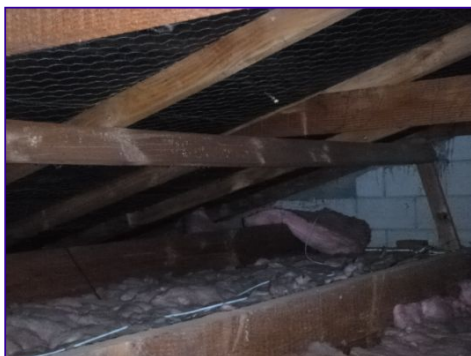
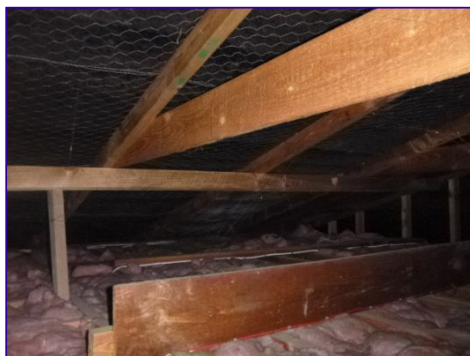
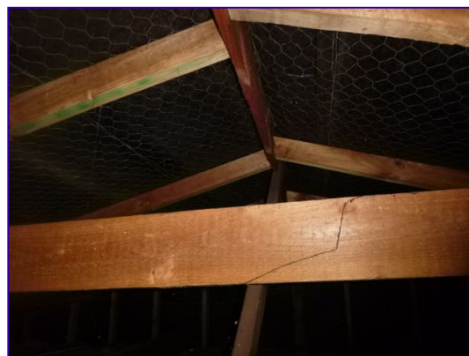
2. Framing Condition

2.1. In average condition attributing to it's age and era

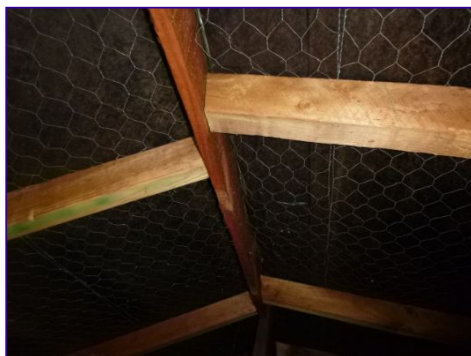
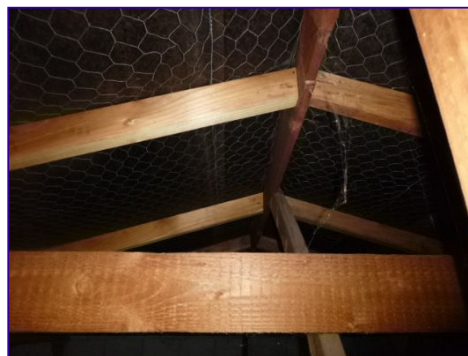
3. Cladding underside Condition

3.1. In dry condition at time of the inspection

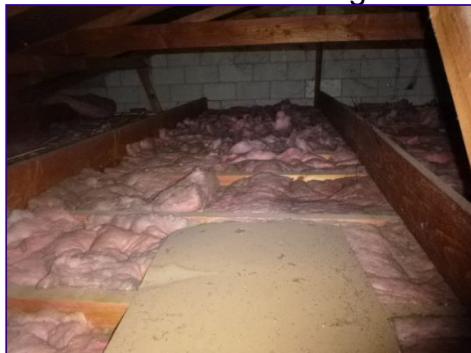
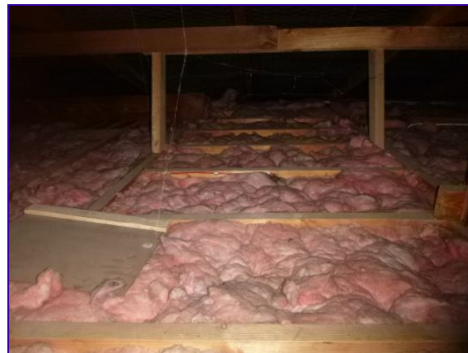
4. Ceiling Insulation

4.1. Insulation is considered low, recommend an insulation contractor upgrades to improve energy efficiency to the home

4.2. Fibre glass 90mm thickness R value 1.7

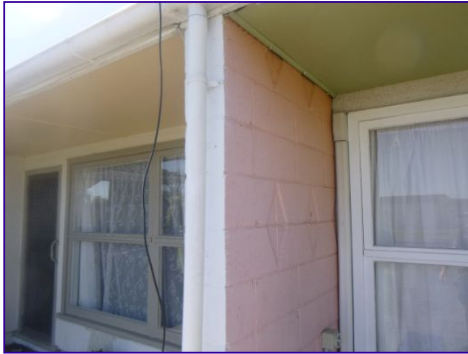
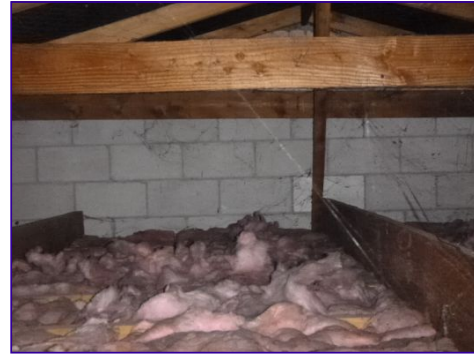
5. Party Wall

5.1. Fire wall is present, however, no guarantee can be given to the fire integrity or performance of this wall in the event of a fire.

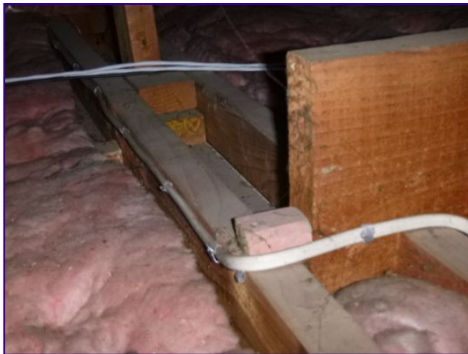
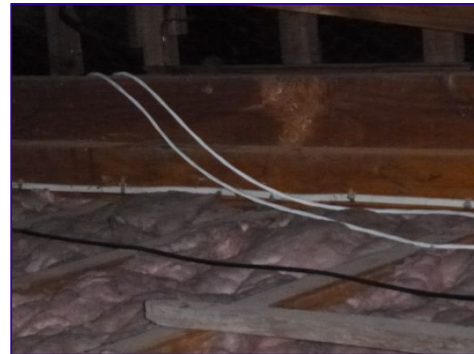
6. Electrical Comments

6.1. TPS electrical wiring installed, no concerns observed at the time of inspection

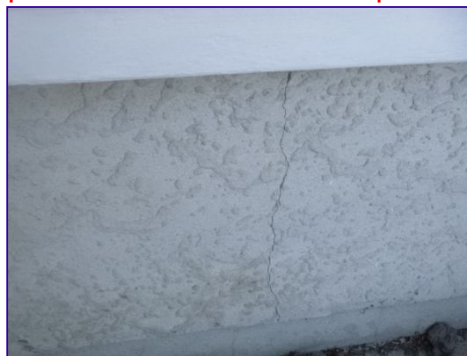
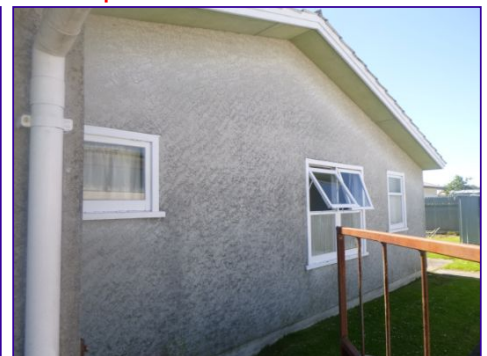
South West wall

- 1.4. Mould/mildew observed, recommend soft washing walls to prevent moisture retention
- 1.5. **Damaged fibre cement cladding observed, caution this product may contain asbestos. It is recommended a licensed builder competent in handling possible asbestos containing materials tests and repairs/replaces as required to make safe and prevent water ingress**

- 1.6. **Minor cracks observed to render in areas. Recommend an exterior plasterer repairs/seals to ensure adequate weather protection**

Recommend repairs to the damaged exterior cladding to ensure adequate weather protection and to make safe

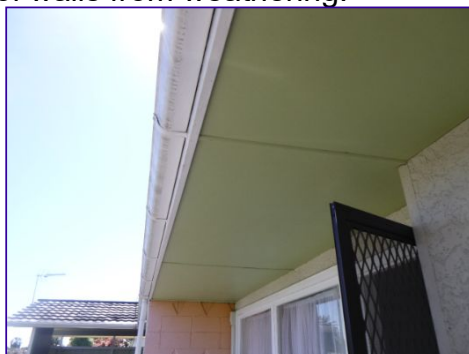
2. Eave/Soffit linings

- 2.1. Caution - Fibre cement linings may contain asbestos. While left non disturbed it is considered safe. If disturbing then testing and the correct safety precautions are recommended
- 2.2. Less than 600mm width, this is considered below average for the protection of walls from weathering.

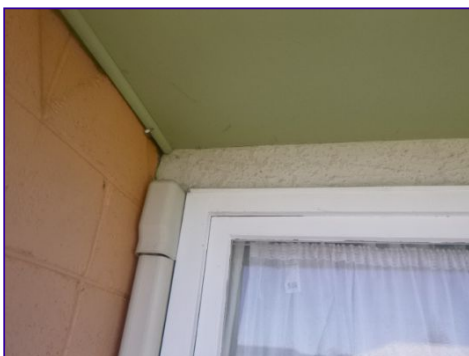
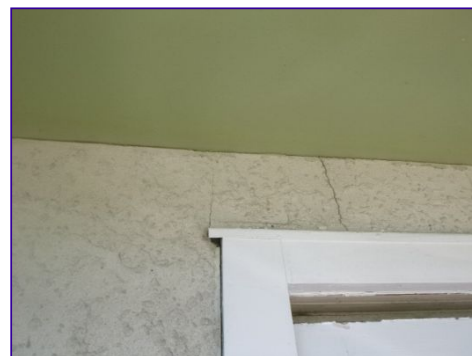
7. Flashings Condition

- 7.1. In serviceable condition at the time of inspection

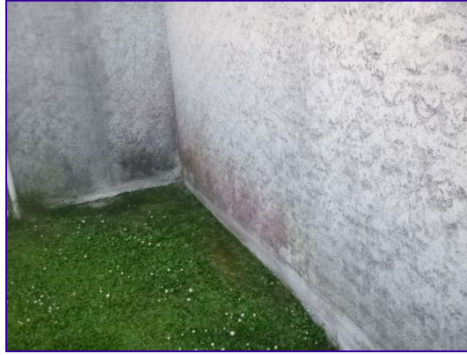
8. Paint condition

- 8.1. Monolithic cladding type installed, it is important to maintain protective paint coating to a high standard to prevent water ingress and any cracking is sealed immediately
- 8.2. Protective paint coating is in aged condition, recommend review by a qualified painter to prep and paint to ensure adequate water protection

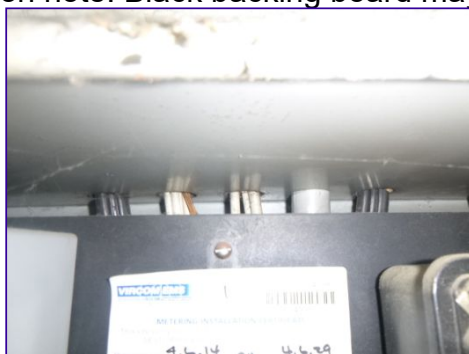
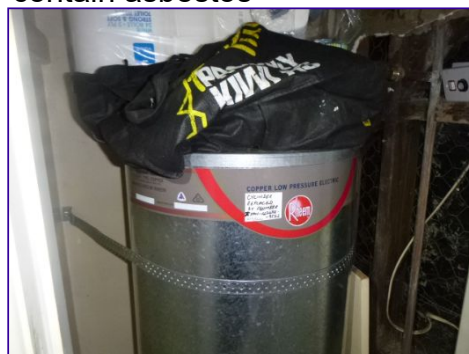
11.1. The electrical wiring appears to be in fair condition.

11.2. Caution note: Black backing board may contain asbestos

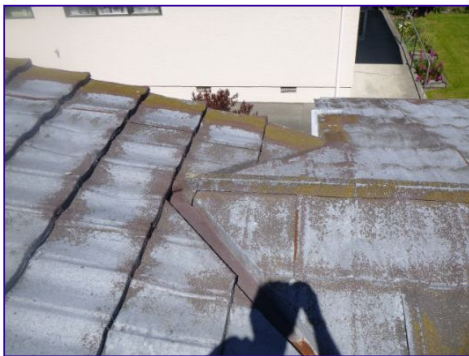
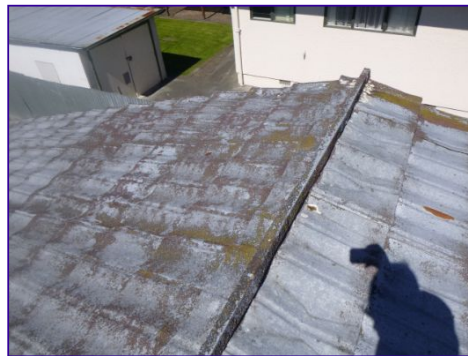
4. Roof Flashing Condition

- 4.1. In average condition at time of the inspection

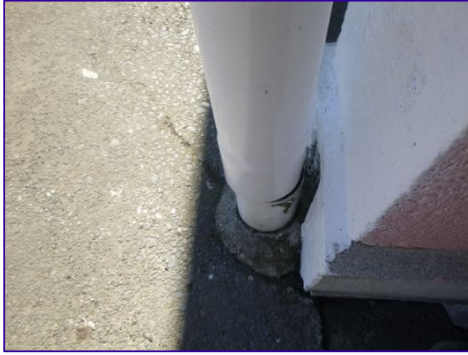
- 7.1. In average condition at the time of inspection, discharging appropriately. Recommend securing gutter to stormwater drain

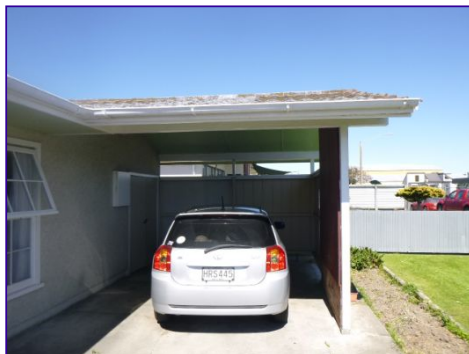
2. Roof Condition

- 2.1. In average condition at the time of inspection
- 2.2. Same as house roof

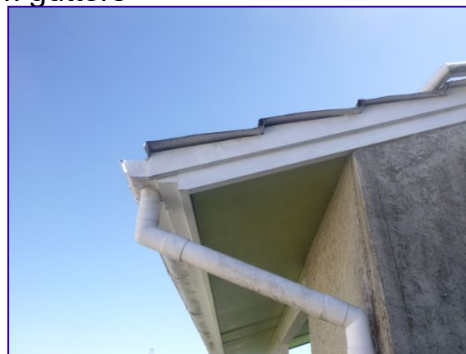
3. Gutter/ Downpipes Conditions

- 3.1. In average condition at the time of inspection, discharging appropriately in the stormwater
- 3.2. Recommend clearing debris from gutters

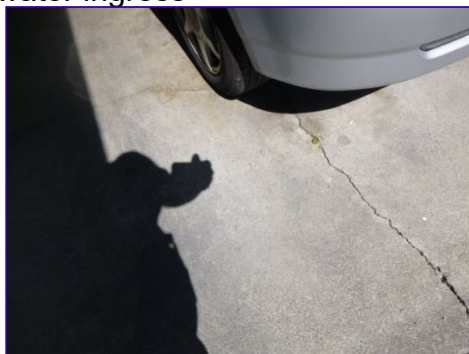
4. Floor Condition

- 4.1. Noticeable cracking observed, recommend sealing cracks as necessary to prevent water ingress

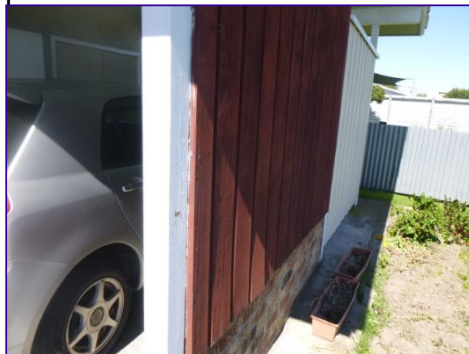
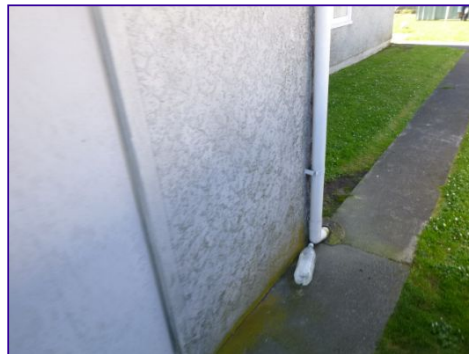
5. Garage Wall Condition

- 5.1. In average condition at the time of inspection
- 5.2. Fibre cement sheet may contain asbestos, recommend washing, prepping and painting to protect and seal
- 5.3. Weatherboard warping, recommend securing and staining where the board to improve condition

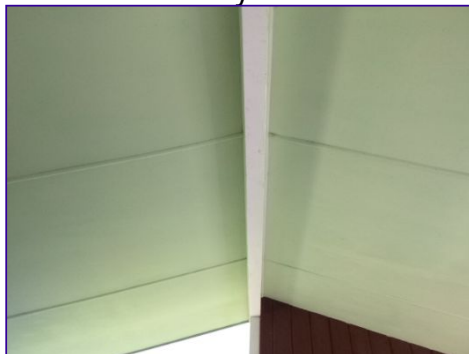
6. Ceiling Condition

- 6.1. In average condition at the time of inspection
- 6.2. Fibre cement sheet may contain asbestos

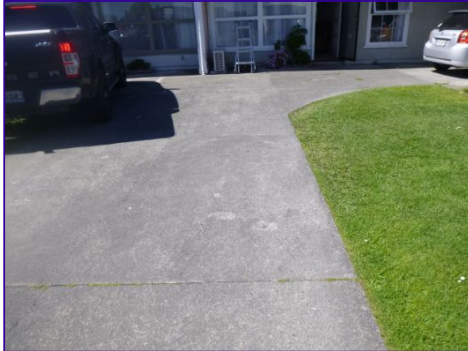
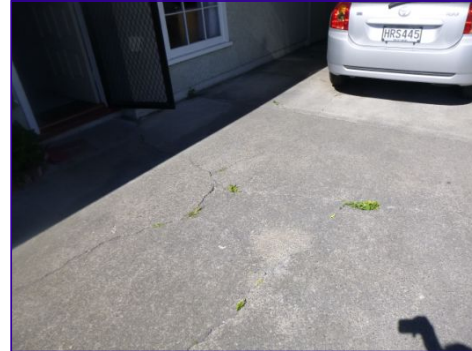
1. Driveway Condition

- 1.1. In average condition at the time of inspection
- 1.2. Common cracks noted, recommend sealing to prevent water ingress

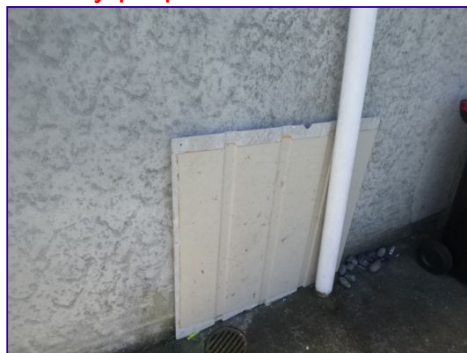
- 3.1. Loose fibre cement sheet may contain asbestos, recommend a licensed builder competent in handling possible asbestos containing materials removes for safety purposes

- Recommend removal of damaged fibre cement panel
- Recommend filling low spot in ground to prevent pooling of water

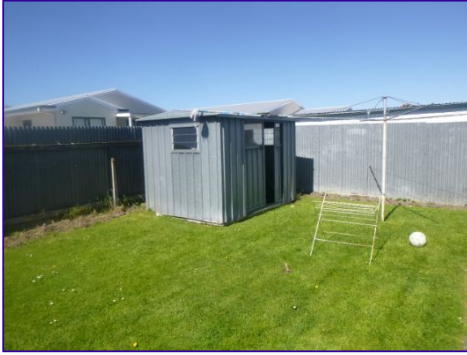
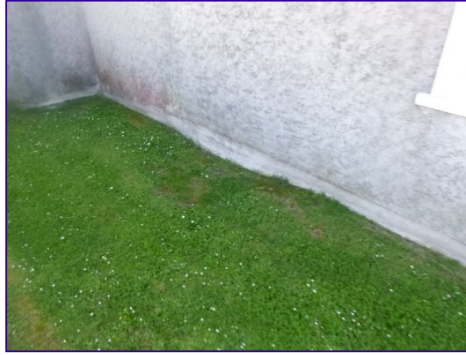
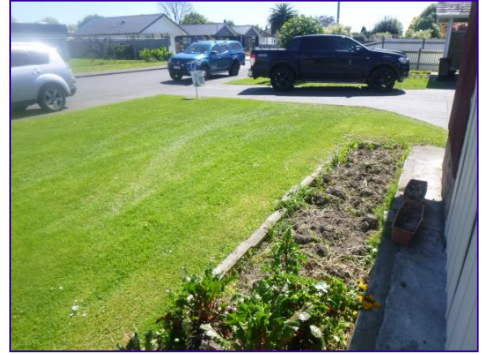
4. Lot Grade and Drainage Conditions

- 4.1. Flat Lot
- 4.2. While performance of lot drainage and water handling systems may appear serviceable at the time of inspection, the inspector CANNOT always accurately predict this performance as conditions constantly change. It is recommended monitoring surface water flow during rain periods, if water flows toward the structure it is recommended assessment by a licensed drain layer
- 4.3. There is a dip in the ground on the right side of home, recommend this area is filled to prevent water pooling near the foundation which can cause seepage and damage

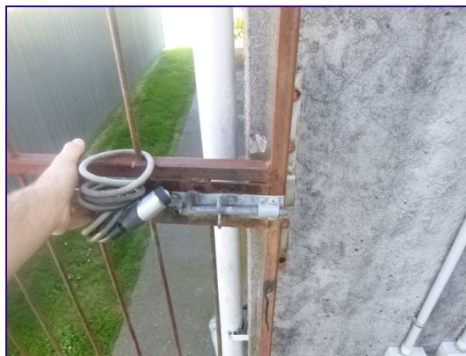
6. Gate/s condition

- 6.1. In average condition at time of the inspection
- 6.2. Gate is out of alignment, recommend adjustment/repairs to restore correct function
