HAWK EYE BUILDING INSPECTIONS OVERVIEW

HAWK EYE
BUILDING INSPECTIONS

OVERVIEW OF HIGH RISK BUILDING MATERIALS

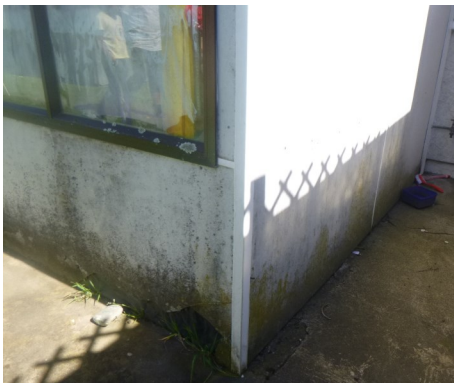
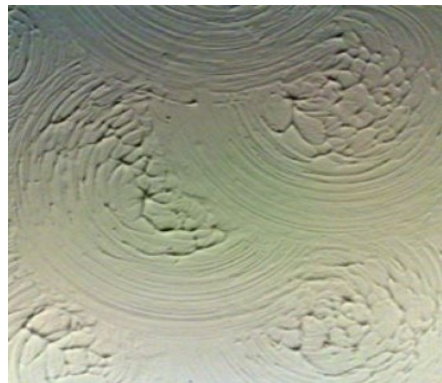
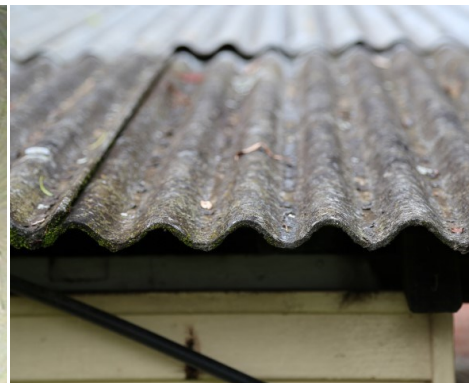
Fibre cement cladding (Fibrolite, Highline, Hardiplank) Fibre cement products are the most common form of ACM in New Zealand homes especially in the soffits, gables and external wall cladding. Do not sand before painting as this can send the dust airborne.

Asbestos-cement roofing (Super six) This is an easier product to identify due to its wider and deeper profile and fibre cement material. If in good condition it can be maintained, it is important to prevent moss growth to prevent moisture retention.

Insulation vermiculite insulation and pipe lagging may contain asbestos. If vermiculite is found in the roof space it is recommended removal due to the risk of disturbing and exposure.

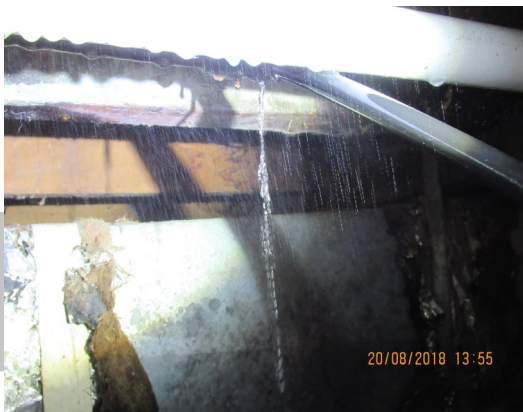
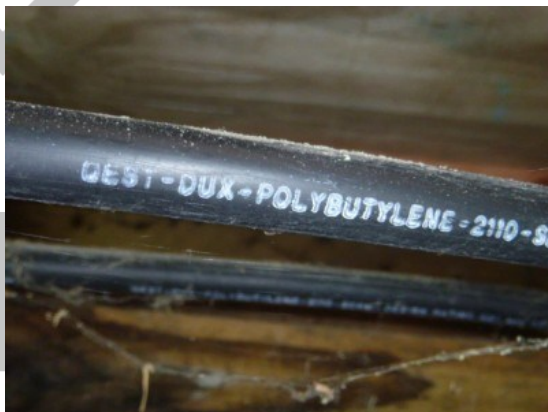
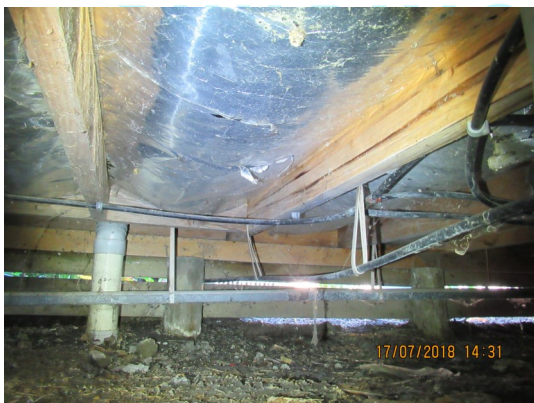
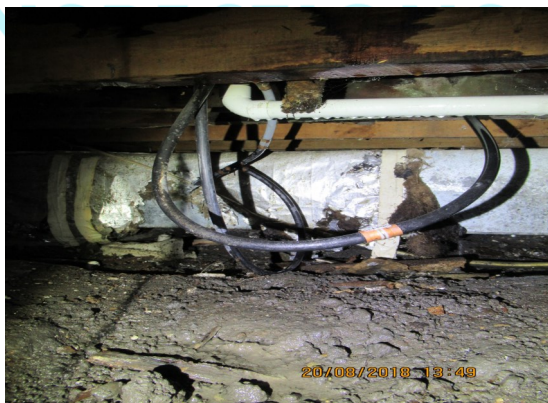
DUX QEST PLUMBING

It is prone for splitting, along the pipes or at the plastic joints, potentially causing leaks throughout your home. If the leak happens behind wall linings/bathroom linings, this can cause extensive hidden damage, and you could be up for expensive replacement costs .

Dux Qest is easily identified. It is distinctive black piping with 'Qest Dux' printed in white lettering on the side. If a property has Dux Qest plumbing, the agent is obliged to disclose this if they are aware .

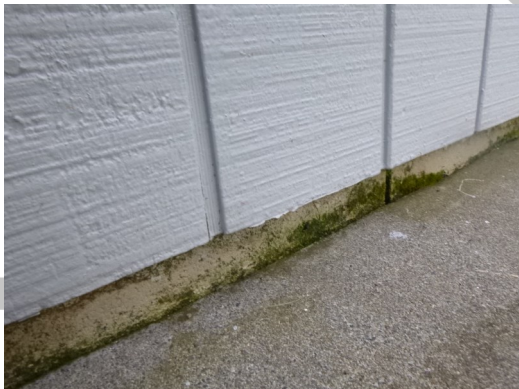
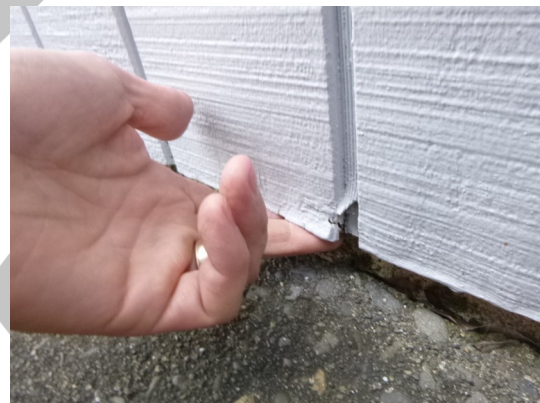
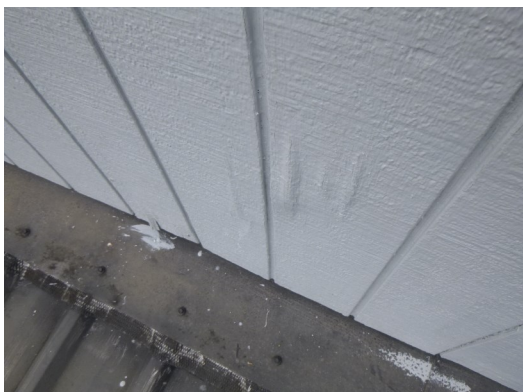
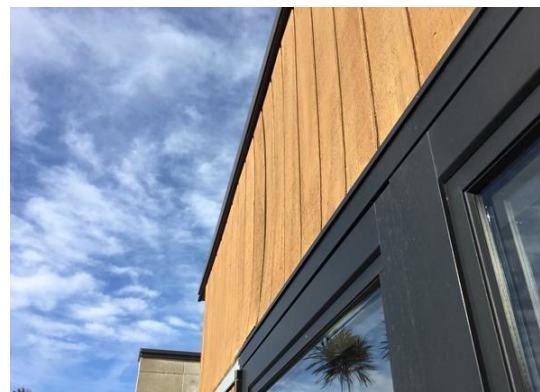
SHADOWCLAD CLADDING

Shadowclad is a vertical pattern plywood sheet product. If looking at a home with this material then keep an eye out for swelling, warping, splitting, extra screws installed, softening of the plywood etc. as these are all signs of deterioration. The more vulnerable areas to look around are where there are low ground clearances or base of cladding, around windows, at overlaps and wall penetrations.

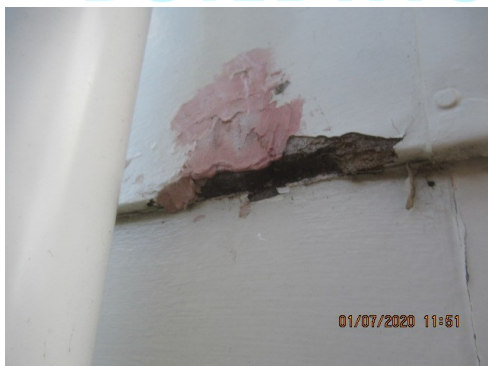
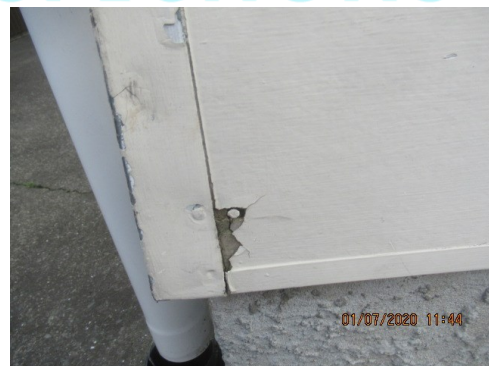
WEATHERSIDE CLADDING

- It is slightly thicker than HardiPlank (10mm).
- The joiners between planks are commonly metal not plastic and wider than HardiPlank joiners.
- The nails are flush with the surface of the cladding rather than protruding.
- If there is any damage that allows you to see the base colour, look out for brown for Weatherside.
- Review the lower boards for rot/deterioration around nail holes.
- Weatherside has a bevelled edge compared to Hardiplank.

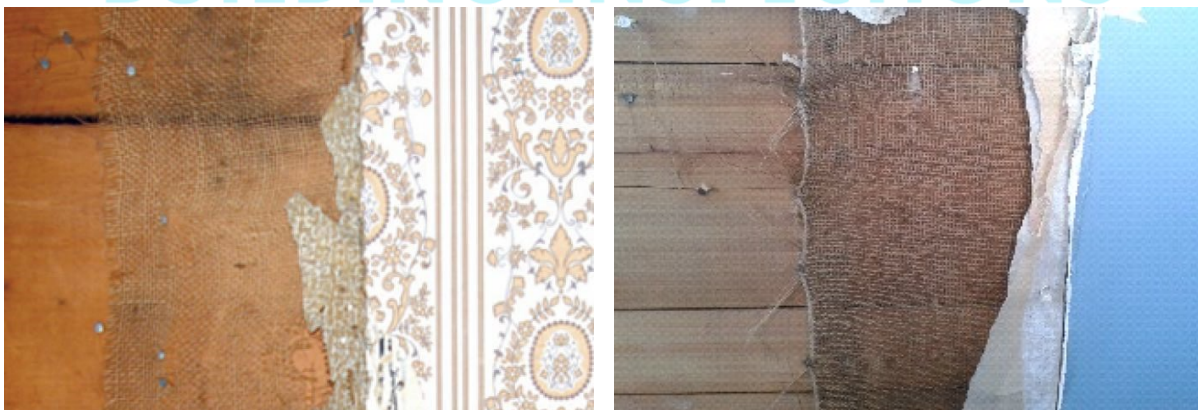
SCRIM WALL LINING

In homes built pre 1935 there is a risk that Scrim (Scrim & Sarking). wall lining is still present. This is a hessian or jute sacking material that has been tacked or stapled on to rough sawn, horizontally placed, thin wooden planks (Sarking).

- The knock test - Sarking (unsurprisingly) feels like knocking on wood. Scrim & Sarking is a very hard surface. Scrim is not always present where Sarking is left
- The floating wallpaper test – Scrim finished by covering the Scrim with wallpaper. Scrim starts coming away from the Sarking and gives the impression of floating, bulging or twisting wallpaper. This is especially obvious in room corners.
- Close inspection – With close inspection you can sometimes see hessian Scrim where wallpaper is loose or has come away.

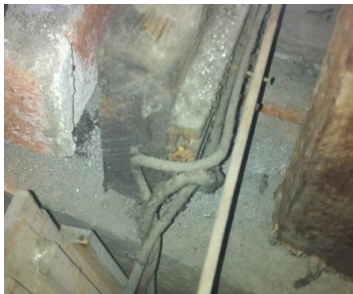
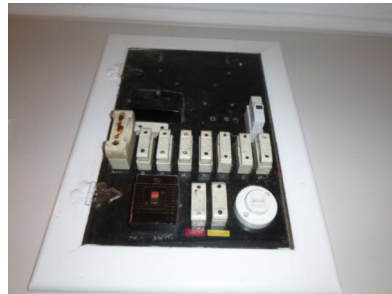
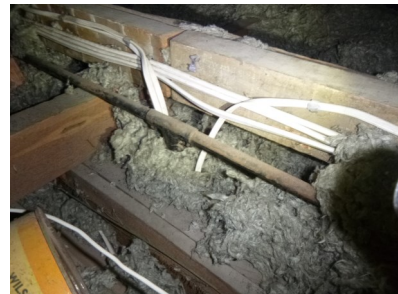
- Older style switches and sockets
- fuses that blow and circuit breakers that trip irregularly
- Flickering/dimming lights
- porcelain fuses in the fusebox, which indicate older wiring - old wiring can be a concern because of the age or type of wiring
- Metal Conduit wiring is an older type wiring encased in a metal surround. We recommend a licensed electrician tests this wiring and advises on condition and replacement requirements due to age
- TRS wiring installed between the 1940's and 1950's. This is prone to degrading and is a high fire risk. TRS is considered a high risk and replacement is recommended by a licensed electrician for safety purposes.

Black backing boards to fuse panels may contain asbestos. If licensed electricians are working around these panels they will need to follow safety precautions
